# MASONRY WALLS ANALYSIS FROM SHISH MAHAL IN LAHORE-PAKISTAN

## ABSTRACT

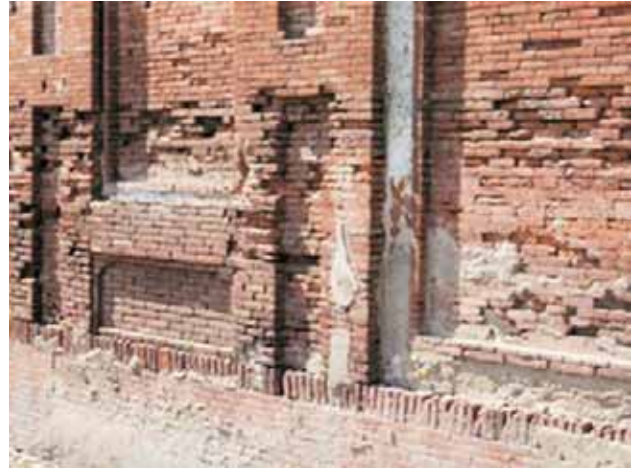
The masonry walls of Shish Mahal remained unnoticed till recently. Shish Mahal has two basements which are visible from outside towards north-west sides. The current poor condition of its walls can easily be seen in Figure 1 and Figure 2. The patches of bricks have been deteriorated from walls and plaster and mortar is removed due to various reasons, but mainly because of weather conditions.

*Figure-1:* Deteriorated bricks.

- All the removed brick patches should be re-fixed with lime mortar.
- Bricks should have the same size and strength as used originally used by Mughals. (Brick sizes detail used by Mughals is given in Table 1, strength in Table 2 and chemical analysis in Table 3).

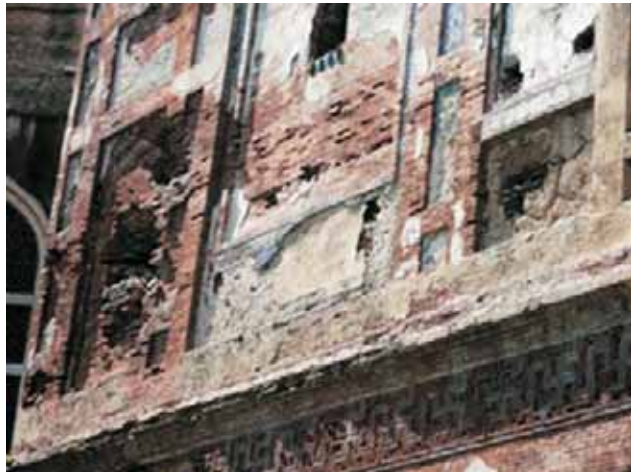
*Figure-2:* Deteriorated patches of bricks.

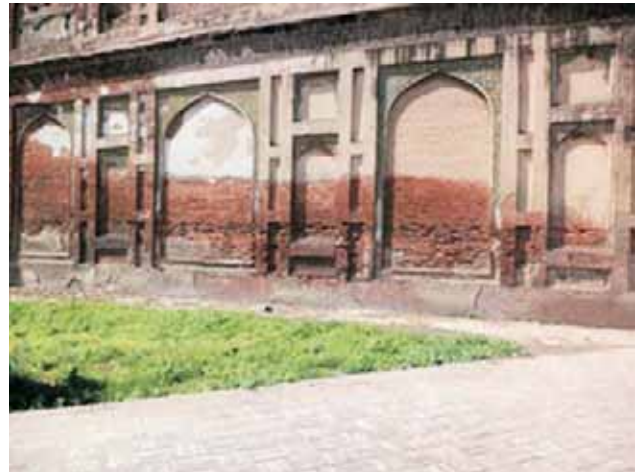
*Figure-3:* Dampness on brick wall.

Unwanted water or moisture was found to be present in the building structures. The dampness created serious damages in structures which were close to water bodies. Dampness not only damaged the building structure but also its finishes and contents. The main cause of dampness was water which entered through different routes. Water generally entered through walls exposed to prevailing rain or moist wind (Figure 3).

Due to gravity water penetrated through capillaries or cracked bricks and mortar joints. In Shish Mahal the dampness on the walls was due to direct exposure to weather conditions. This dampness was due to direct rains and defective drainage system.

The brick joints should be filled with lime mortar. Gutters and down pipes should be rechecked for leaks and cracks. Their joints should be sealed. Blockage in pipes should be released. Raised plinth protection must be provided to avoid penetration of water. Any kind of water body should be kept away from historic buildings. There should be proper ventilation and the existing ventilation in the walls should not be blocked. The Mughal lime plaster with all ingredients should be used. Disposal of rain water on brick walls should be avoided.

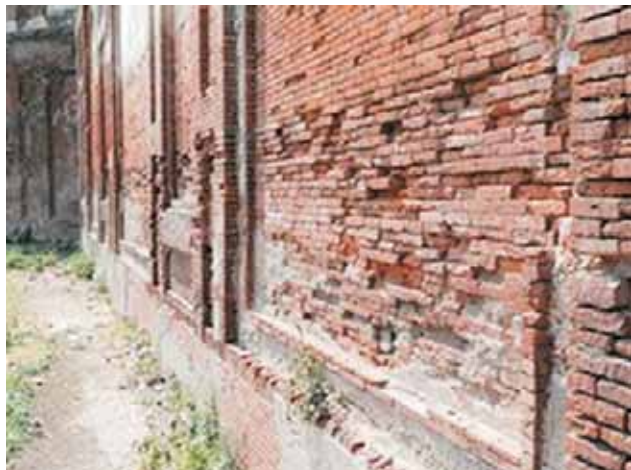
*Figure-4:* Erosion of mortar from brick wall.

The function of mortar is to bind the bricks; it provides adhesion between the bricks. Mortar has eroded from the masonry walls of Shish Mahal (Figure 4).

The bricks have also been deteriorated due to erosion of mortar. The reason for this erosion is water penetration leading to the concentration of moisture, dampness, plants growing on the walls and presence of salt crystallization.

If proper materials are used for mortar and lime plaster with skilled hands, then erosion could be avoided.

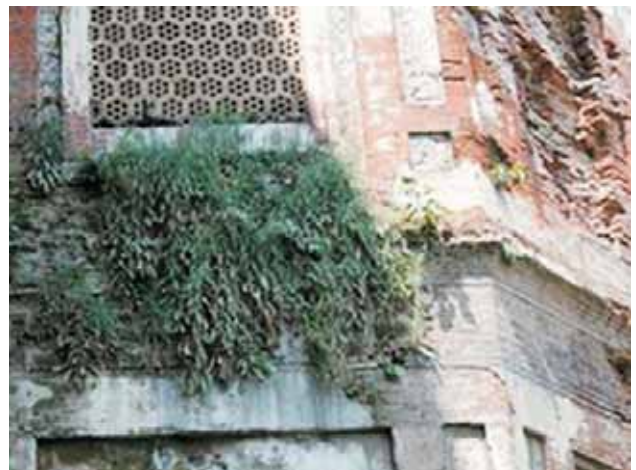
*Figure-5:* Fungal stain and plantation.

Fungus has occurred due to presence of water or high moisture content in masonry walls. Plantation is seen on masonry walls of Shish Mahal (Figure 5). Fungus flourishes in damp environmental conditions having high humidity and lack of ventilation (Lourenco, et. al., 2006). Fungus also flourishes in water disposal areas of walls of Shish Mahal. The plantation is also due to seeds present in the fecal dropping of birds, specially pigeons. The mortar joints and holes in walls provide shelter and a suitable ground for any seeds to grow. The roots go deep into the walls causing deterioration, cracks and water penetration.

The fungus problem can easily be controlled if moisture and dampness is controlled. There should be no room in the walls for growth of seed which comes through birds. The walls should be examined time to time for growth of any vegetation.

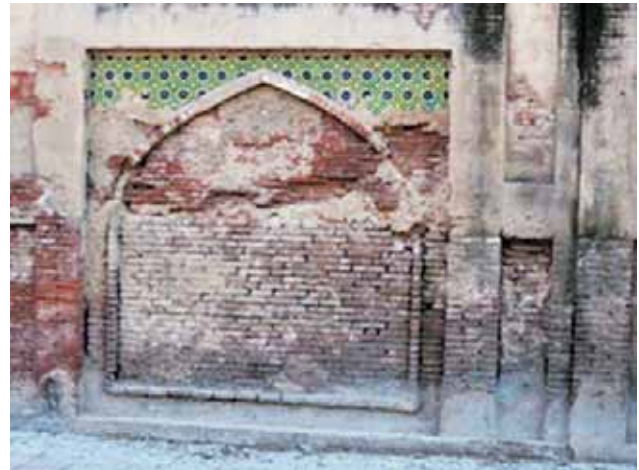
Defective plaster rendering was observed at many places in the Fort as well as on the walls of Shish Mahal. Due to hot climate these defects of rendering were caused by evaporation, air pollution, condensation, thermal stresses, dehydration and biological attacks arising from penetration of rain. The other causes may be growth of plants, presence of animals, insects and traffic vibration. The plaster rendering has cracked due to shrinkage or movement in substrate itself. Figure 6 shows defective plaster rendering of Shish Mahal.

Figure-6: Defective plaster rendering of Shish Mahal

- After the bricks have been fixed the walls need to be plastered with original *kankar* lime plaster, which was originally used by the Mughals.

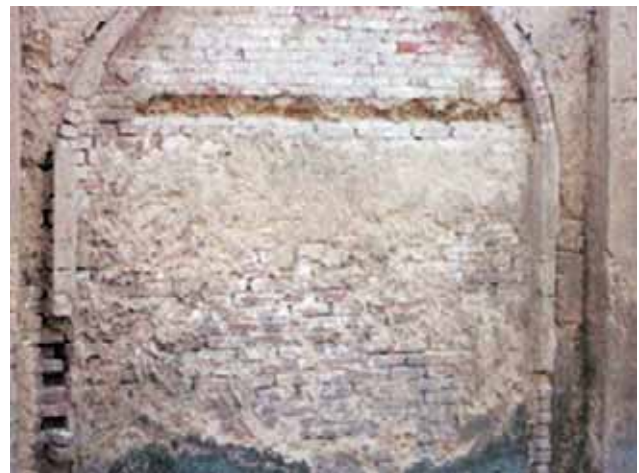
Proper planned restoration has never been done for the walls of Shish Mahal. Repairs have been done from time to time but not in an effective manner. Restoration is not something which can be done by any technician or lover of antiquity, but should be undertaken only by experienced and qualified experts. This always demands supervision by competent authorities and is the work of skilled craftsmen. Poor conservation was one of the main reasons for deterioration of masonry walls. The use of wrong material and incompetence of staff has made the situation worse (Figure7).

Figure-7: Poor conservation of Shish Mahal

To avoid bad repair works skilled staff should be appointed who knows the worth of historical antiquities. Material used should also be according to the desired standards.

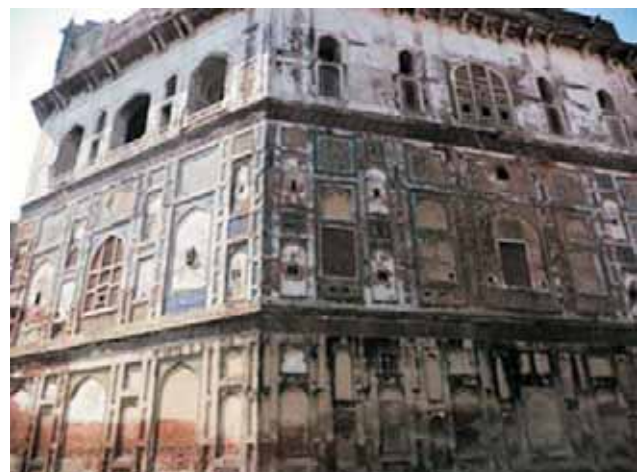
General neglect was another cause of deterioration of the bricks of masonry walls of Shish Mahal. A number of issues like economic, political, social and lack of awareness were the underlying causes of neglect (Figure 8). Neglect might be due to an individual, a community, an agency or the state itself.

Figure-8: Neglect of wall of Shish Mahal

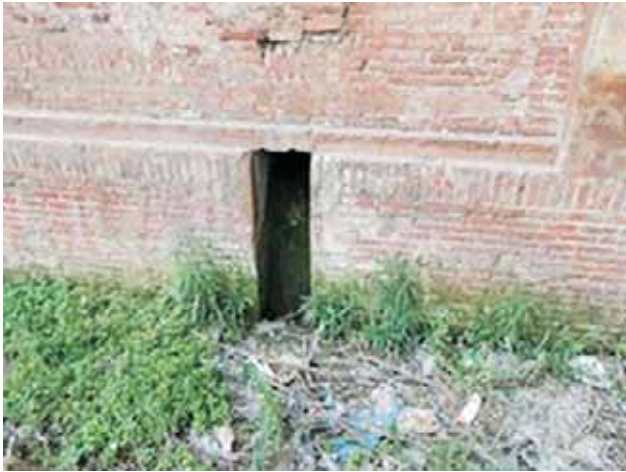
The drainage system is an important element of any structure. Proper drainage system saves the structure from dampness and other side effects due to accumulation of water. Poor drainage is another main cause of deterioration of bricks at Shish Mahal. In the rainy season water collects along the walls of the Shish Mahal which results in the growth of unwanted plantation. Another thing noticed is the garbage collection along the walls of the Fort, due to which water is collected and causes dampness (Figure 9).

Figure-9: Garbage along water disposal

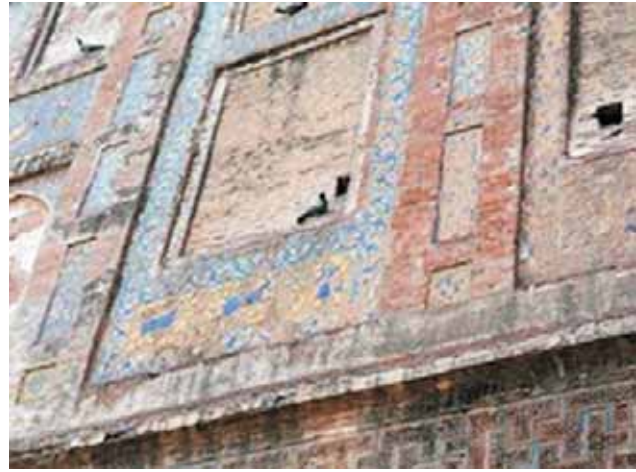
Figure-10: Destruction due to pigeons

Pigeons also create problems in building structures especially in city centers. They occupy loose roof coverings and block gutter pipes with feathers, causing water penetration and consequent decay. Pigeons are also responsible for bringing seed through germination and eventually causing unwanted plantation (Figure 10).

Spaces could be created for pigeons or other birds in nearby vicinity. Measures should be taken to keep the birds away from historic monuments.
