NED CITY CAMPUS RESTORATION SETTING BENCHMARKS FOR CONSERVATION PRACTICES

3.1 Restoration of Bai Puribai Becharbhai and Bercharbhai Raichand Block

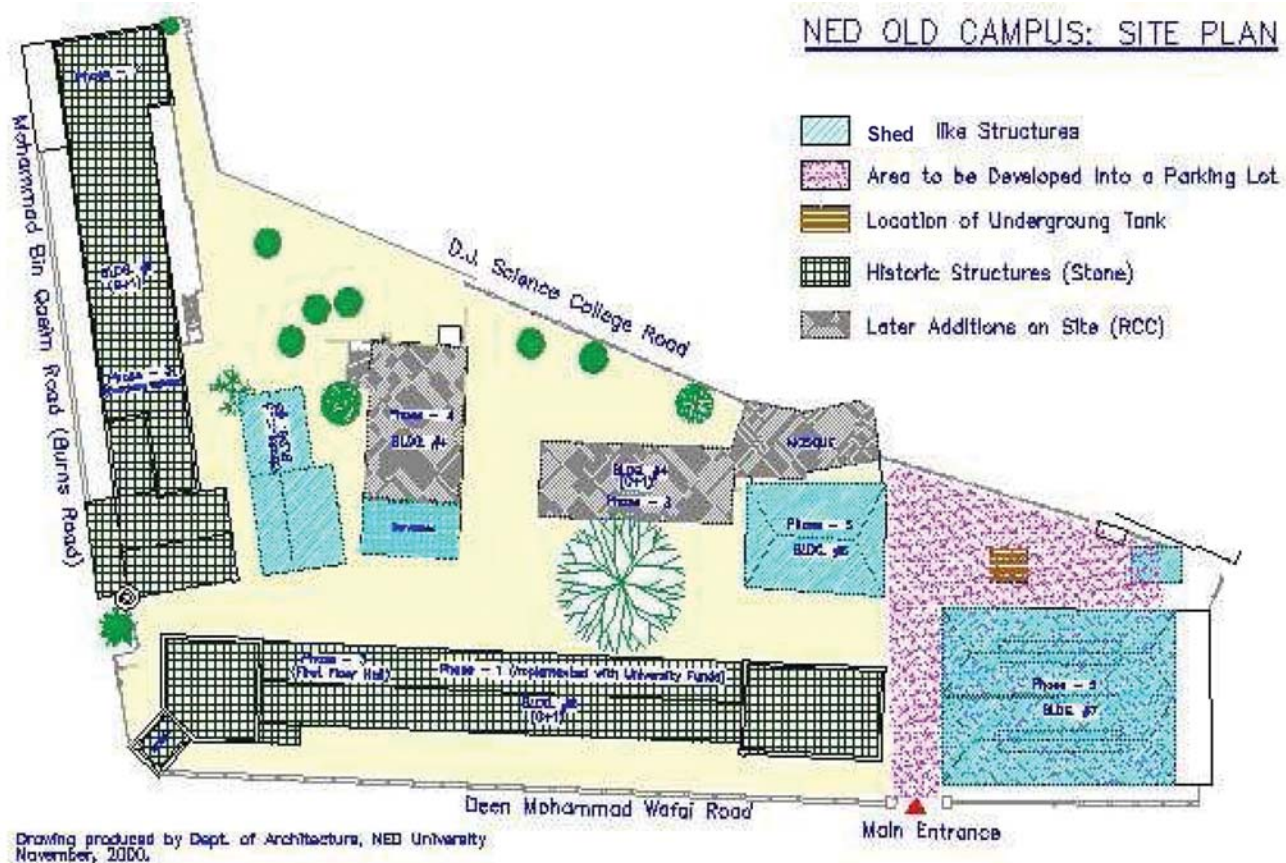
Figure-2: The site as documented before restoration interventions.

NED City Campus is a 1.67 acres trapezoidal plot, having several building blocks added to the site at different stages of its history [Figure-2]. Of these the two main historic structures built in yellow Gizri stone align along the two main roads; whereas four other smaller structures built in RCC are located in the inner core of the plot. Other than these structures of a more permanent nature, there were few shed-like constructions which were dismantled to clear up the site for required additional spaces planned to be built in the later phases of the project. The historic structures of the campus have a very modest architectural vocabulary; however

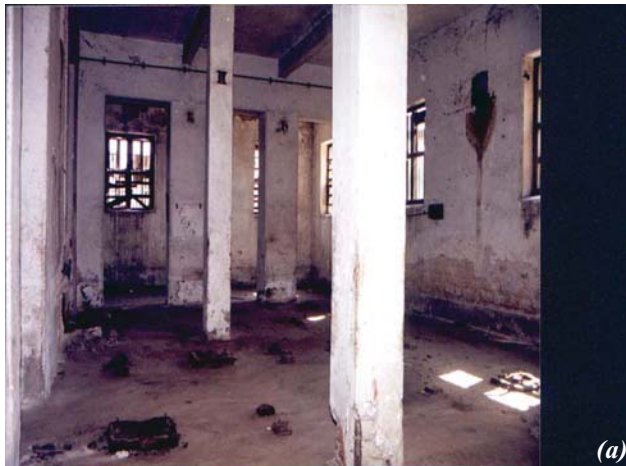
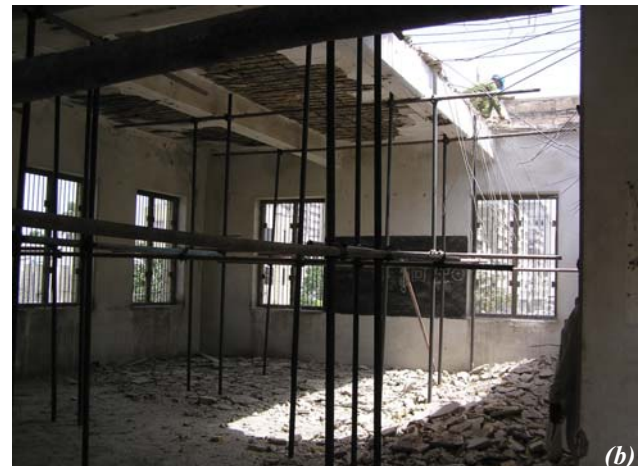
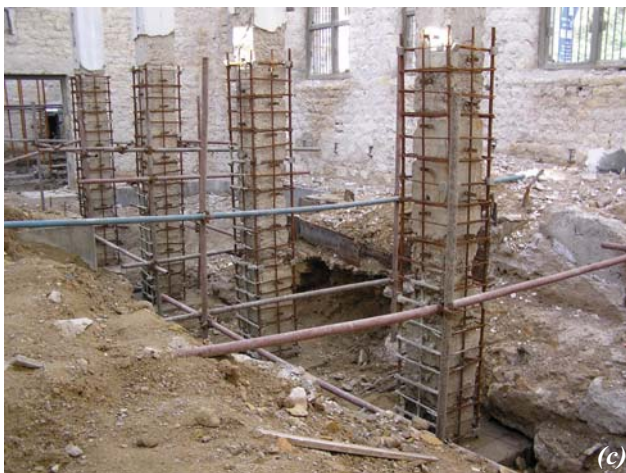
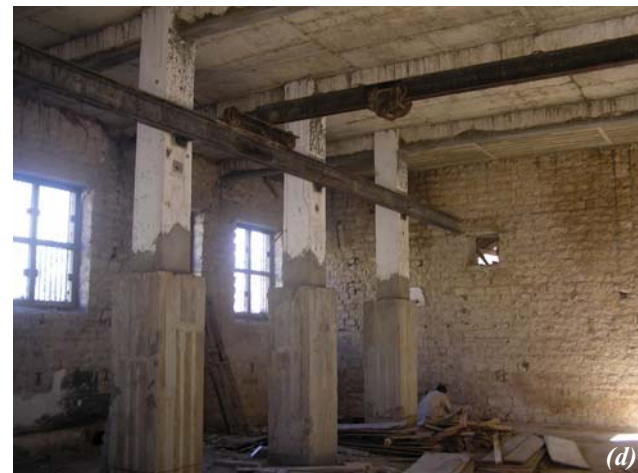
Figure-3(a-d): The restoration process cycle; (a) Deteriorated bases of the RCC column. (b) Temporary propping for relief of loads and chipping/ surface preparation of beams. (c) Reinforcement details for strengthening of lower half of columns. (d) The columns after jacketing; at curing stage.

The most challenging intervention involved restoration and enhancement of the lost strength, stiffness and ductility of deteriorated structural members for the reasons already discussed in the above sections. A workable repair strategy can only be designed if causes and effects of involved deterioration process are well established. Compatibility of repair material with the existing material is also vital for durable repair. A careful investigation was undertaken for each component of the structural system and a well-designed repair strategy was then applied after establishing the desired choice of strengthening. The slabs in all cases were completely demolished and re-cast. The steps sequentially followed include; temporary strutting of beams followed by careful demolition of slabs using manual labor, and then measures for re-strengthening and re-casting structural

members [Figure-3(a-f)]. Once the site was cleared of all debris the damaged base of all columns was re-strengthened by first extending their footing and then jacketing of columns with added reinforcement. The damaged portions of beams were then treated; first chiseling out the damaged concrete cover and then treating the reinforcement with anti-corrosion paints and finally applying the repair plasters using bonding admixtures and strengthening fibers mixed with cement and sand. After re-strengthening of the columns and beams the slabs were cast; and the mid-lofts designed using steel were added to increase floor area and achieve optimum utilization of voluminous ceiling heights. The structural repairs were followed by repairs of interior finishes. Giving due importance to original materials the damaged lime plaster of internal wall surfaces was re-placed with plaster of similar composition as that of original and in-situ c.c. flooring to recreate the effect of original flooring.

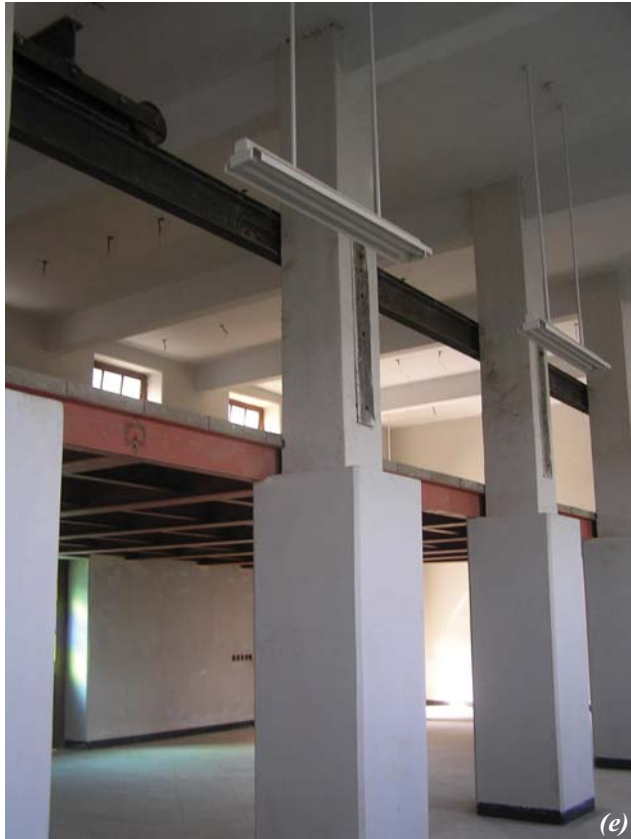
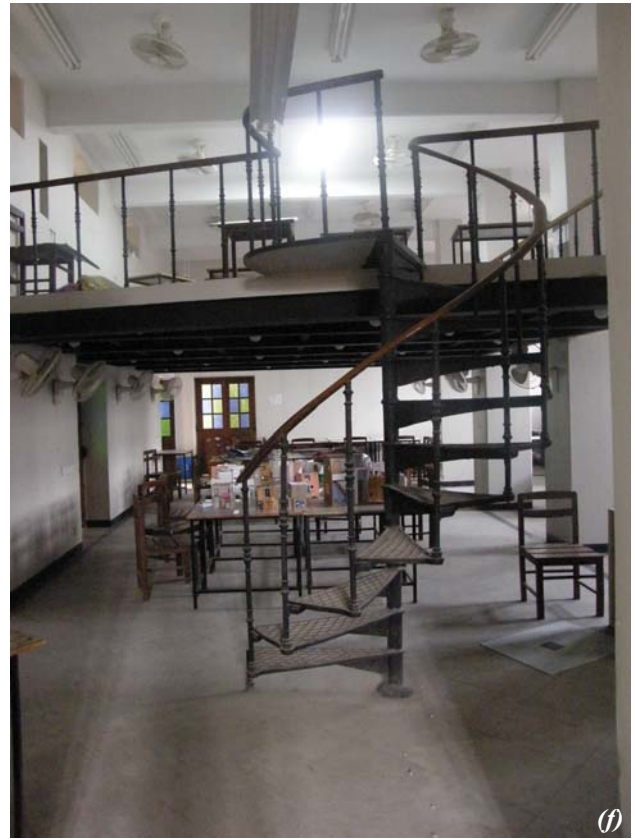
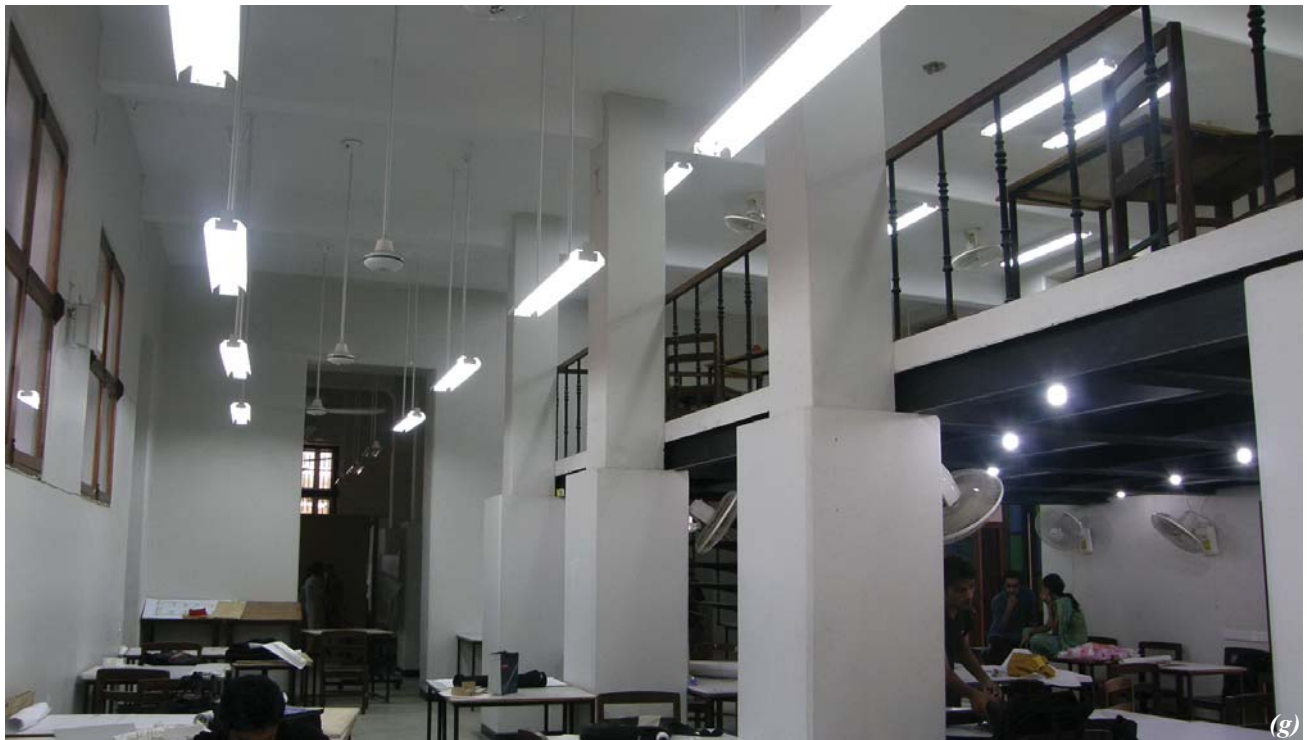
Figure-3(e-g): (e) Repaired columns with mid-loft. (f & g) View of the space after completion.

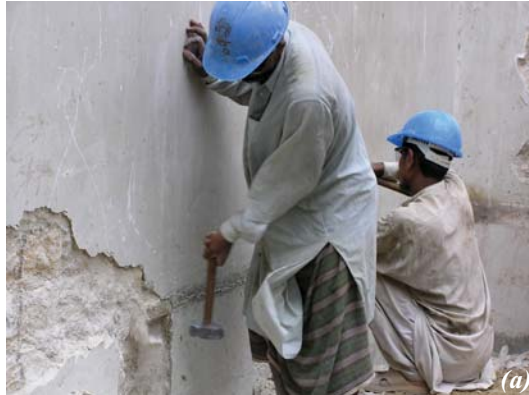
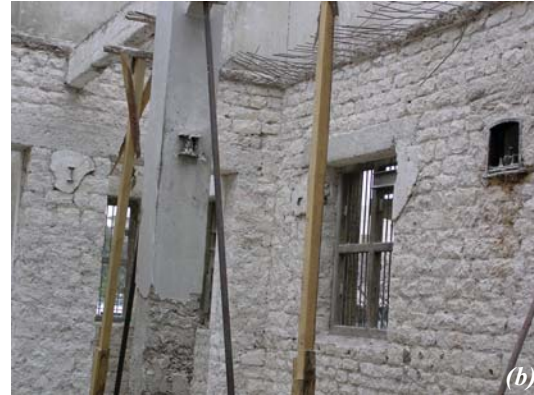
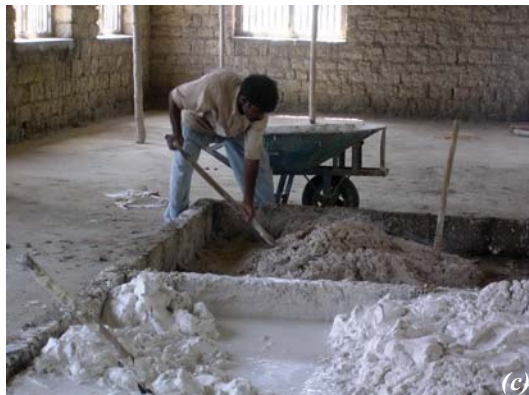
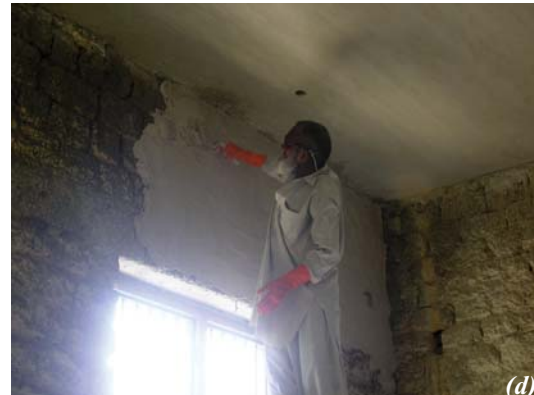
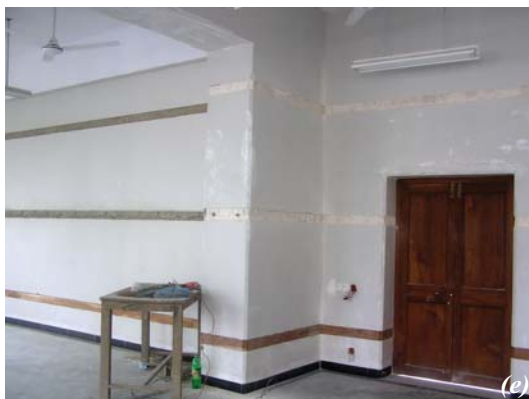
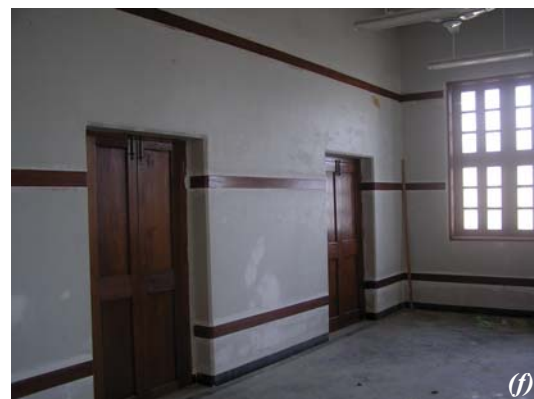
The original lime plaster inside the building had been badly damaged due to seepage of rain water from window/ventilator openings and roof slab. The extent of damage made it necessary to re-place it with new plaster. On removal of plaster layer cavities in masonry wall were also discovered. These were filled with lime mortar grouting before application of the new plaster. Lime plaster was prepared on site;

Figure-4(a-f): Lime plaster of stone masonry walls. (a) Removal of existing damaged lime-plaster. (b) Stone masonry walls as exposed after complete removal of existing plaster. (c) Making lime-plaster. (d) Applying the new lime-plaster. (e) Masonry walls before complete finishing of plaster surfaces. (f) Masonry walls after complete finishing of plaster surfaces.

following all the steps employed in traditional practice: dissolving the quick lime lumps in water, draining the dissolved liquid through wire mesh into pits dug in ground for slaking of lime - and left for two to three weeks, mixing the slaked lime with jute, sand and crush of lime stone for preparation of lime mortar and grouting, and finally application of lime plaster in two layers [Figure-4(a-f)]. Identification of an expert craftsman to deal with this specialized task took several months and trials to accomplish.

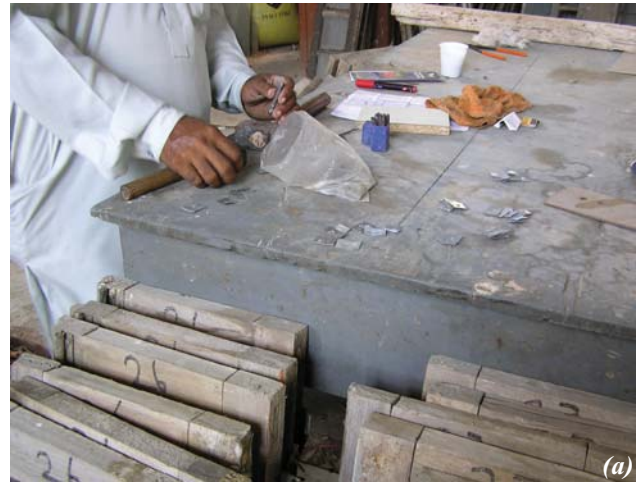
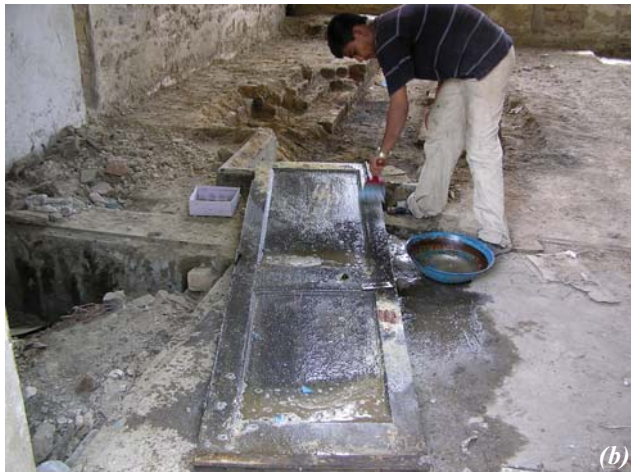
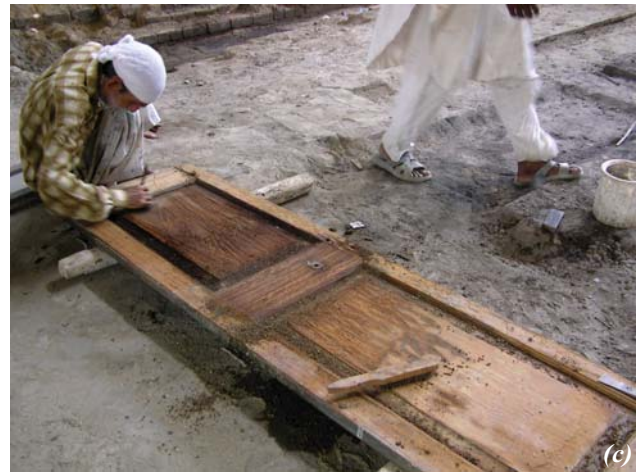
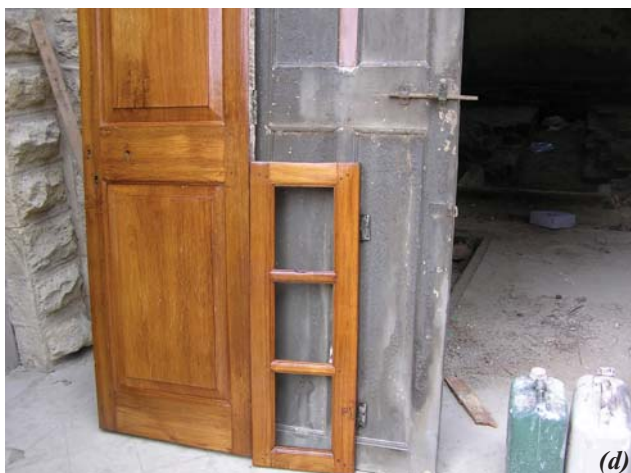
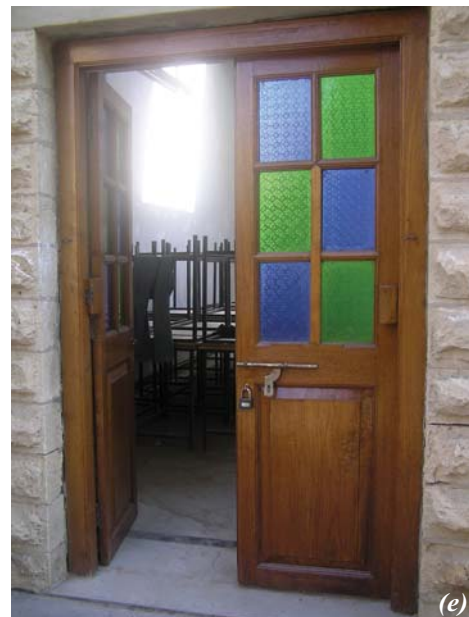
Figure-5(a-e): Cleaning and polishing of timber works. (a) Tagging and numbering of door/ window shutters. (b) Application of solution to soften existing paint layers. (c) Scrapping of paint layers and smoothing of timber surfaces. (d) Polished finish of cleaned timber elements. (e) Final finished door panel.

All timber elements in the building were in a state of disrepair and damage, requiring specialized restoration procedure. For this purpose all door, window and ventilator shutters were dismantled, and tagged with numeric identification corresponding to their location [Figure-5(a)]. The accumulated paint layers were then cleaned following a three stepped process; applying a solution of caustic soda diluted in water with a brush on all surfaces to soften paint, then scrapping off the paint layers manually with metal scrappers, and finally smoothing of surfaces with fine sand paper [Figure-5(b-c)]. The original timber texture was enhanced with (matt) clear varnish applied in several coats till desired finish was achieved [Figure-5(d-e)].

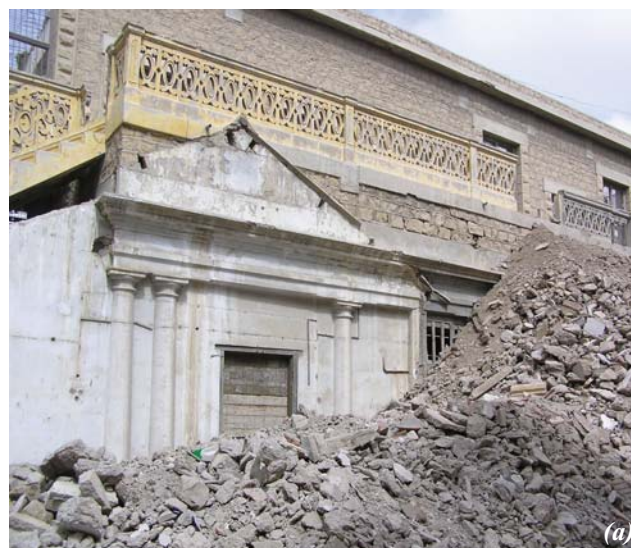
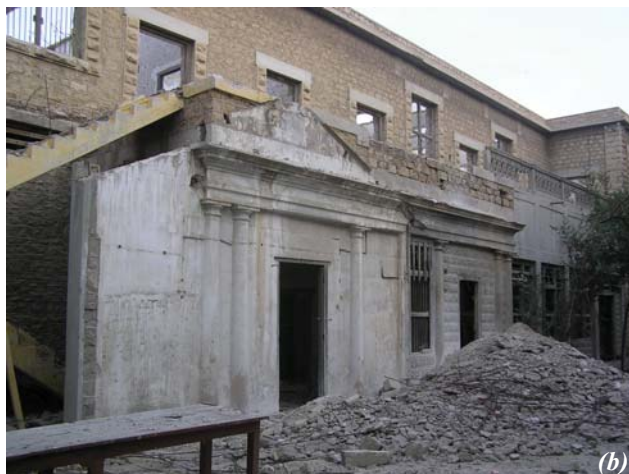
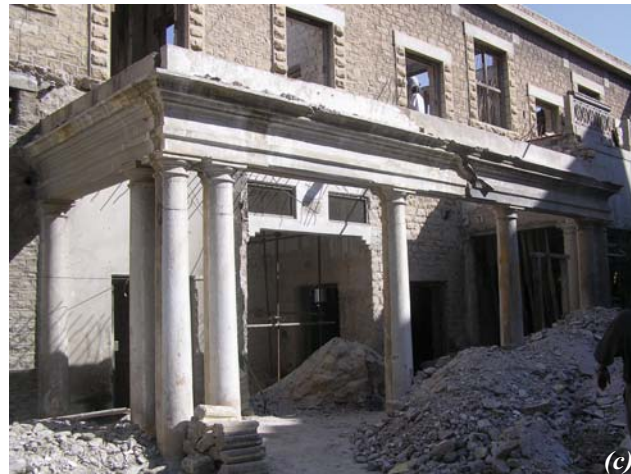
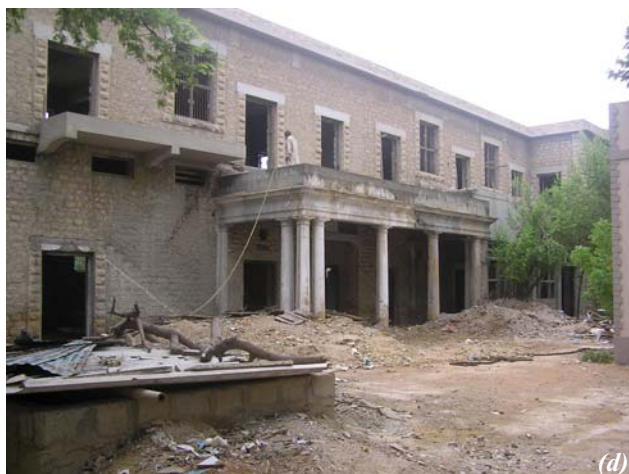
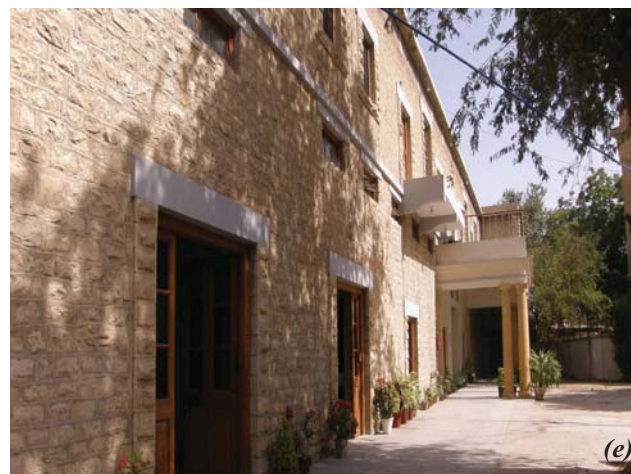
Figure-6(a-e): The entrance portal in building #1. (a) Entrance portal embedded inside later additions. (b) Removal of later additions. (c) The carved out entrance portal. (d) At the stages of repairs and re-cast slab. (e) The restored entrance portal at completion of works.

The modest architectural language employed in design of this historic stone structure makes use of few enhancing architectural features; entrance portal being one of these had a high degree of importance, thus had to be liberated from the later additions that defaced it completely [Figure-6(a-d)]. The external staircase (already being in a precarious condition) and masonry walls embedding the entrance portal were demolished to carve out the entrance portal. The stone surfaces of portal columns were cleaned of all paint layers and damaged cornices were repaired. The restored entrance portal now forms part of the terrace space that opens out from first floor studios [Figure-6(e)]. As a safety measure a new parapet of simple design was introduced around the terrace. A new staircase bearing a contemporary mark was

introduced inside the building. These new interventions are clearly identifiable as later additions.

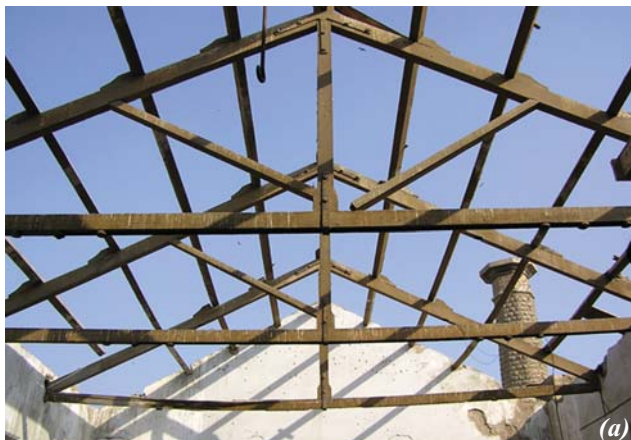
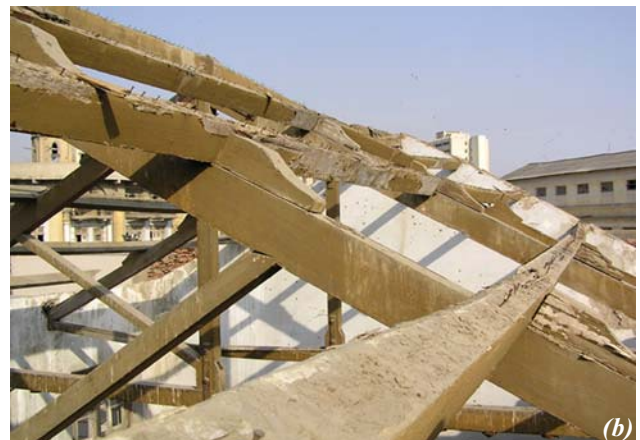
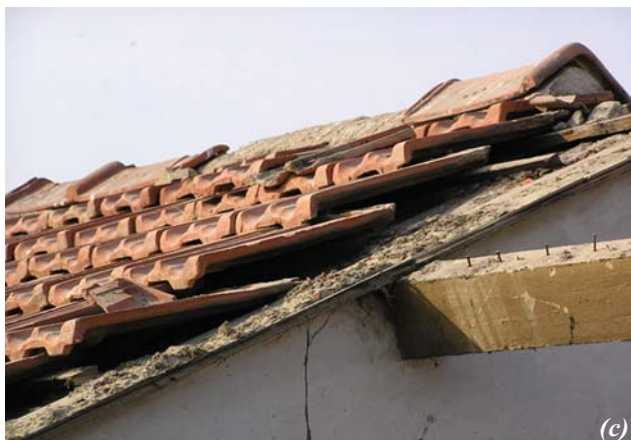
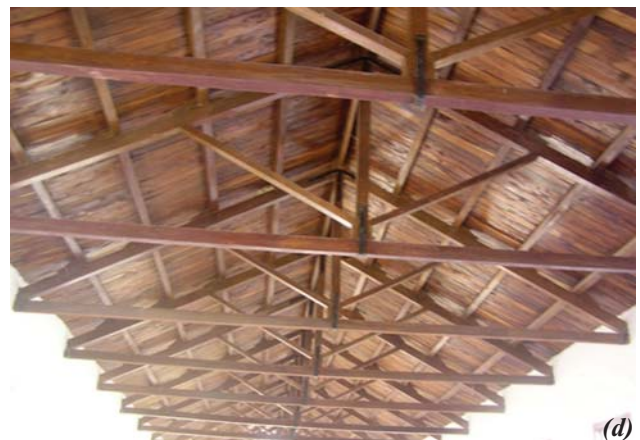
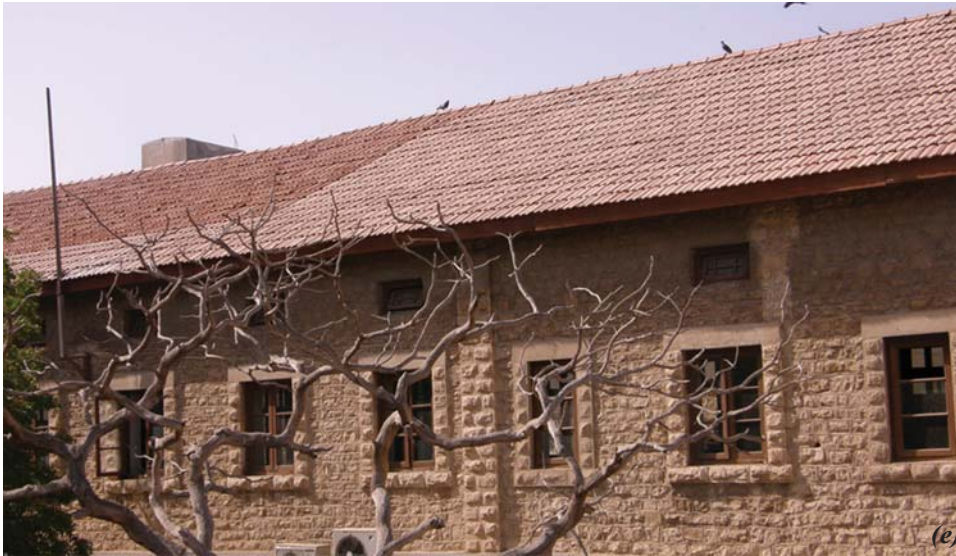
Figure-7(a-e): The original timber pitched roof spanning over a large hall on first floor of Seth Fatehchand Khilwani Block (building #2) was in a highly dilapidated condition with most of its purlins infected with termite. Only the completely destroyed timber was replaced whereas all the original trusses were cleaned and treated with protective timber coating. The terracotta tiles were also re-used; only the damaged ones being replaced. Since the complete restoration of this space as an 'exhibition and display hall' is still on hold due to lack of funds it is becoming more and more difficult to keep the restored roof in a maintained condition.

Besides major restorations undertaken for Bai Puribai Becharbhai and Bercharbhai Raichand Block, there were a number of other works that required urgent attention; the restoration of timber pitched roof in Seth Fatechand

Khilwani Block (building #2) [Figure-7(a-e)], boundary wall on all three sides of the plot [Figure-8(a-b)], restoration of shed for tuck shop [Figure-9(a-b)], construction of new toilet blocks and the structural repairs in building #5. These works were accomplished as part of the first phase of the project. The second phase of the project includes construction of additional spaces for an auditorium, model-making/carpentry workshops, materials laboratory, administrative/faculty offices, basement parking, landscaping of outdoor spaces between buildings for use as sitting areas by students/visitors and complete restoration of building#2. Interior works for exhibition hall, NED gallery, reference library and a few other spaces are also required to be taken up in the future. Proper cleaning and treatment of all stone façades using scientific methods is also planned, but could not be taken up due to funding constraints. A specific timeline for completion of the entire campus restoration cannot be envisaged as the implementation of proposed works is dependent on availability of funds; for which ongoing efforts on part of the administration are continuing.

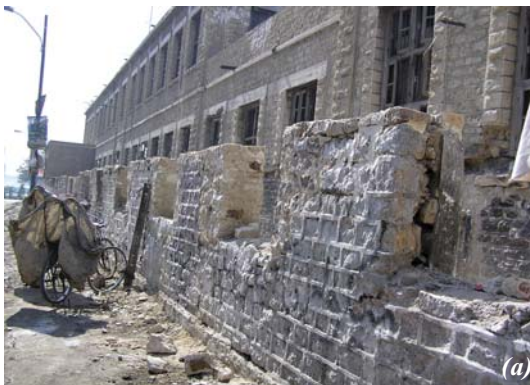
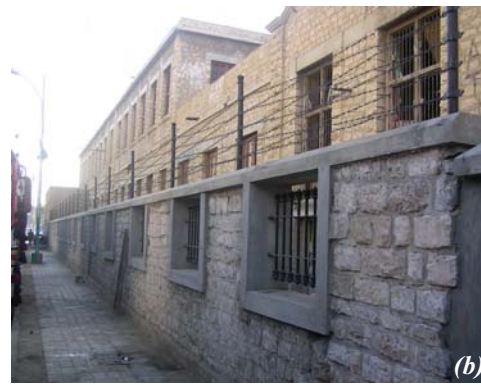
Figure-8(a-b): Restoration works along the Burns Road boundary wall involved demolition of RCC slabs built along the space between the building and the wall. These spaces had been in disuse for many years and became a hideout for drug edicts; a menace now removed from the vicinity due to clearing of area and restoration of the wall.

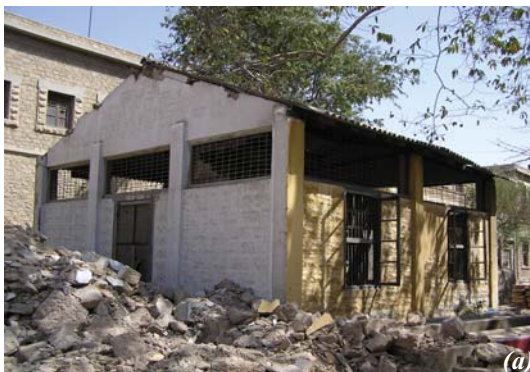
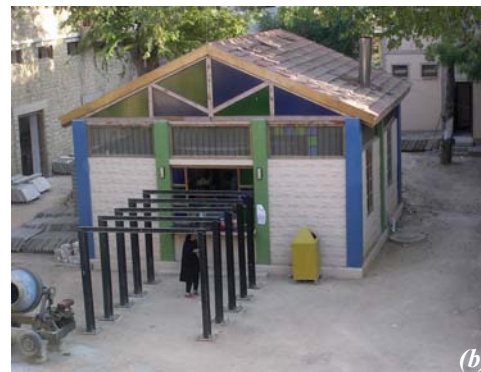
Figure-9(a-b): A small shed restored to serve as a tuck shop. The open spaces around this structure are planned to be properly paved and landscaped for use as outdoor sitting areas.

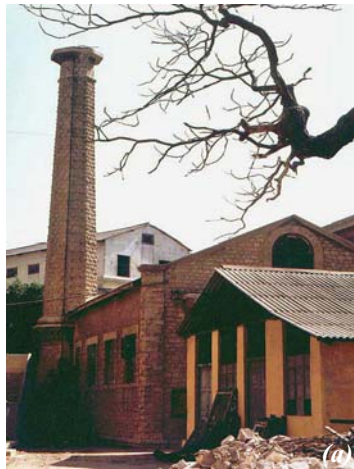
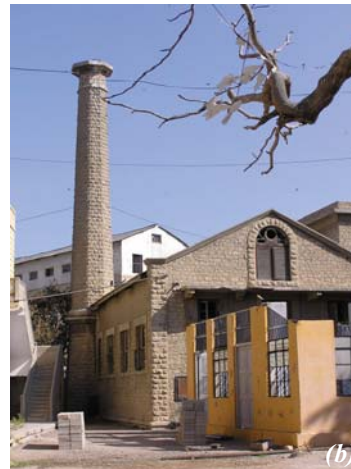
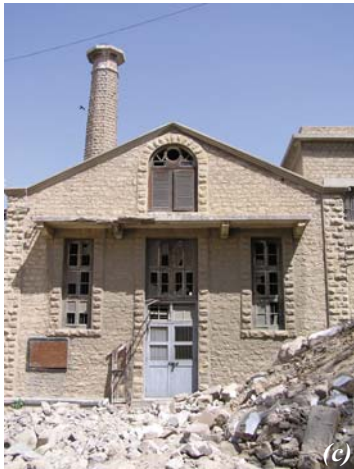
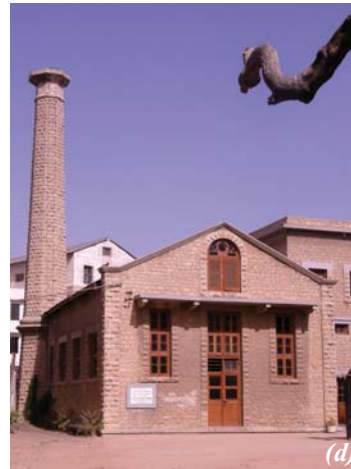
Figure-10(a-d): The pitched roof and chimney room in Baipuribhai and Becharbhai Block; the only space in this block awaiting complete restoration and interior works to house the proposed 'NED Gallery of Historic Archives and Souvenir Shop'.
