MAKLI HILLS MONUMENT THATTA: HISTORY, ARCHITECTURE, CONSERVATION*

*Qasim Ali Qasim**

ABSTRACT

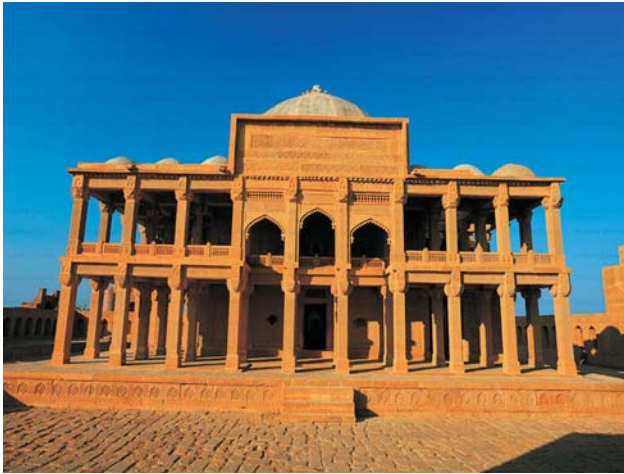
Figure-6: Tomb of Isa Khan Tarkhan on the Makli Necropolis

The tomb of Isa Khan Tarkhan II, completed in 1644, is the most imposing stone building at Makli Hill. The tomb, which stands in a large enclosure surrounded by high stone walls, consists of a large domed chamber, surrounded by a pillared gallery in two storeys. The upper storey of the gallery is roofed by a series of small domes. Richly carved surface tracery is the dominant feature of the decoration, supplemented by honeycombed capitals, and fine arabesques. Many patterns may be identified as modified copies of tile-work.

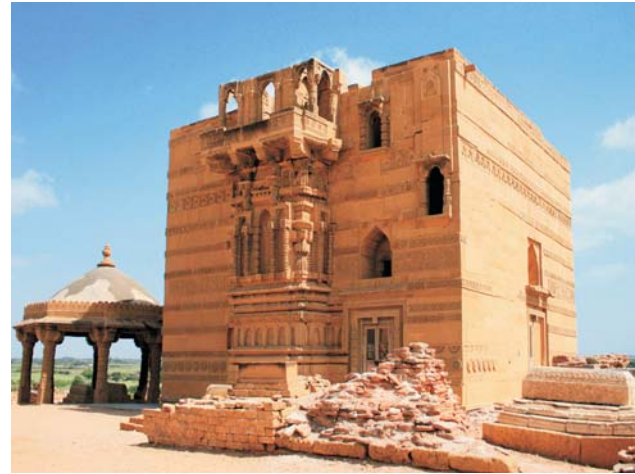
Figure-7: Tomb of Jam Nizam Uddin on the Makli Necropolis

(Figure 6). The third group which occupies the extreme north represents the Samma Period (1351-1520) (Figure 7). It comprises of the tombs of Jam Nizam ud Din, Mubarak Khan, Malik Rajpal, a mosque and some canopies built over the unidentified graves. The hallmark of the architecture of Thatta is the variety of forms and techniques of decoration. Since architecture is determined, inter alia, by its environment, and represents the aspiration and genius of its people, the architecture of Thatta also bears the distinct marks of its variant ancestry, and shows independence from the imperial style of Delhi.

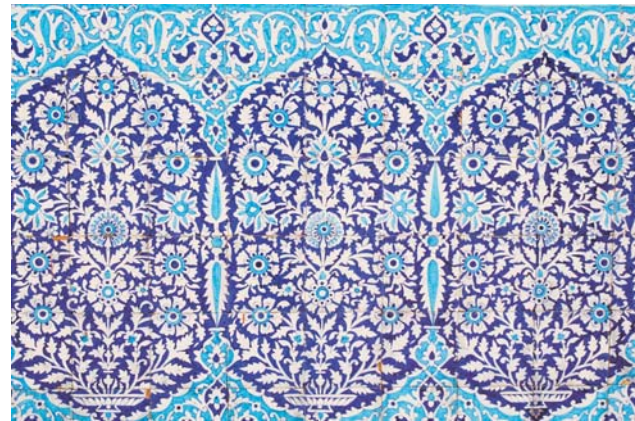
Figure-8: Tiles of Thatta

The monuments here are built both in brick and in stone. The bricks used in the monuments are made of the best clay, and have clean edges, while the brick work in the buildings of Thatta is a superb example of craftsmanship. On the brick buildings, broad planes and simple surfaces prevail. In the absence of mouldings, these brick buildings would have been rather dull, but the superb glazed tiles and their colours more than compensate for the lack of this feature. As a matter of fact, the tiles go a long way to relieve the drab environment of the dry area. The glazed tiles, varying in shade from dark purple to light green and blue, are used in ornamental schemes of diverse geometrical and floral patterns. These tiles have been lavishly used in dados, panels and spandrels of the arches. In some buildings, plain and enamel faced bricks have been alternatively used, with pleasing effect. The white lines, visible in between the glazed and plain bricks, are only imitation joints of white enamel, while the real joints are generally invisible. The tiles of Thatta are different from those used in buildings at Multan, Lahore and Delhi. Their texture and patterns betray the dominant influence of Iran, modified to suit the local taste (Figure 8).

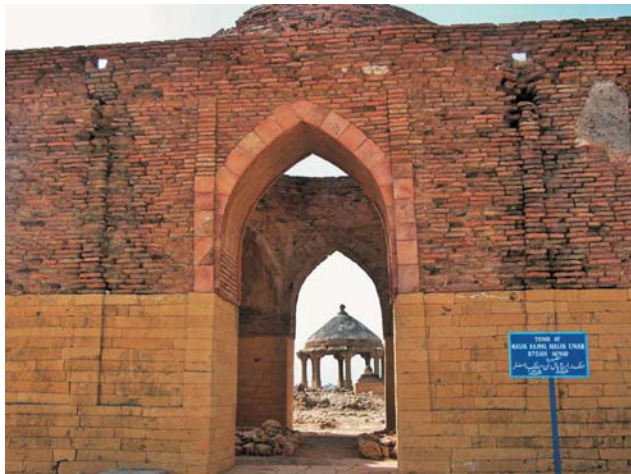
Figure-9: Tomb of Malik Rajpal on the Makli Necropolis

with jewellery, delicately carved in contemporary patterns. The early tombs datable from 14th and 15th centuries AD built in stone, are characterized by the octagonal pavilions standing on pillars, and surmounted by chhatris (canopies with corbelled domes). The pillars and lintels of these canopies are richly carved. The other popular type in this group of early tombs is the square chamber type. The tombs of Mubarak Khan, sister of Fateh Khan, Jam Sikandar Shah and Malik Rajpal, belonging to the Samma dynasty, fall in this group (Figure 9). The most imposing specimen of this type is, however, the tomb of the famous Samma ruler Sultan Nizamuddin, popularly known as Jam Nindo, who died in 1508. It is a square unfinished chamber, completed only up to the springing point of the dome. The corners of the square chamber are cut off by squinches, to carry the circular courses of the dome. Externally, the projecting back of the mihrab surmounted by a balcony constitutes the main feature.

The beauty of the tomb lies in its minute and profuse stone carving, bearing considerable Hindu influence, particularly noticeable in the pillars of the balcony, the miniature sikhara on the projecting back, and a band of geese on either side of the projecting back. The hands of carved stones in relief running round the walls, with designs including full and half blown lotuses, and arched panels with sun flowers, are the chief decorations. A band of excellent *tughra*, and interlaced Arabic inscriptions, provide fine example of calligraphy used as decorative motifs.

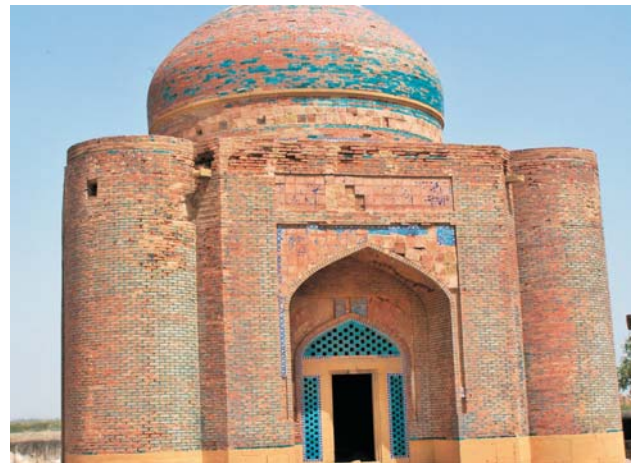
Figure-10: Tomb of Diwan Shurfa Khan on the Makli Necropolis

The best preserved building on the Makli Hill, Diwan Shurfa Khan's tomb, is unparalleled for its massive structure and

solid appearance (Figure 10). It is a square structure with heavy round towers at the corners, and surmounted by a Persian dome originally covered with light blue glazed tiles. The simple, yet attractive colour scheme produced by red bricks, alternating with light blue, provides a pleasing effect. Diwan Shurfa Khan was a minister of Nawab Amir Khan, and the tomb was completed during his lifetime in 1638.
