REVITALIZING HISTORIC AREAS; LESSONS FROM THE RENOVATION OF SAIDPUR VILLAGE, ISLAMABAD

*Samra M. Khan**

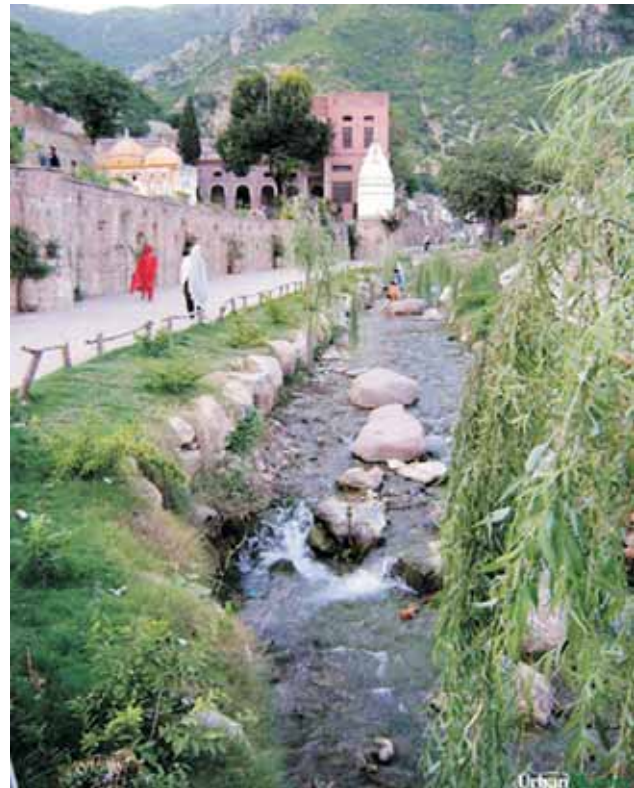
The major historical buildings on site were a Mandir, a Sikh temple and a *dharamshala* (Figure 2). This temple complex was located on a raised platform surrounded by chequered marble flooring (Figure 3). There were old banyan trees here, an existing old wall and an arched entryway, with steps leading from the complex into the main street. These buildings came under the umbrella of the Auqaf Department and the *dharamshala* had been converted into a girls' school in order to protect it from demolition. The *mandir* and the Sikh temple were small structures (measuring 15x15 ft) and stood on two sides of the complex opposite to each other. The original flooring of the complex had marble tiles commemorating people's donations for the *Gurdwara* (Place of worship for the Sikhs) complex over many years. This was an important part of the structure's history.

Figure 2: Saidpur Village before renovation
Source: www.urbanpk.com accessed 20-3-2010.

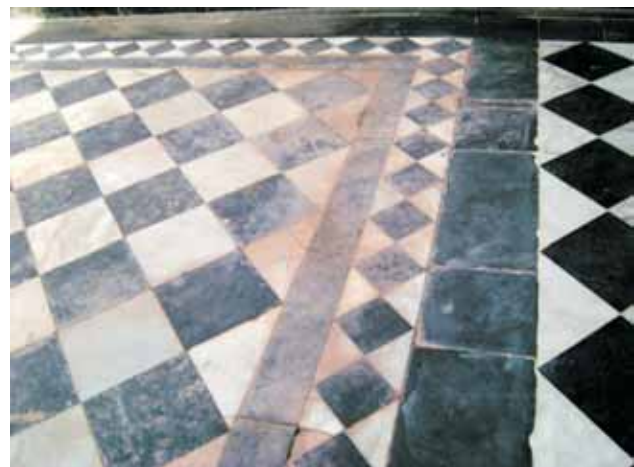
Figure 3: Marble Flooring outside the *dharamshala*

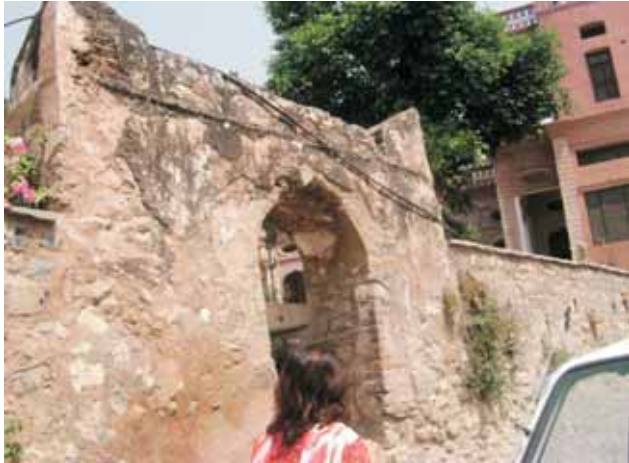
The old archway connected the temple area with the road running through the village center (Figure 4).

Figure 4: Old Gateway leading to the temple complex

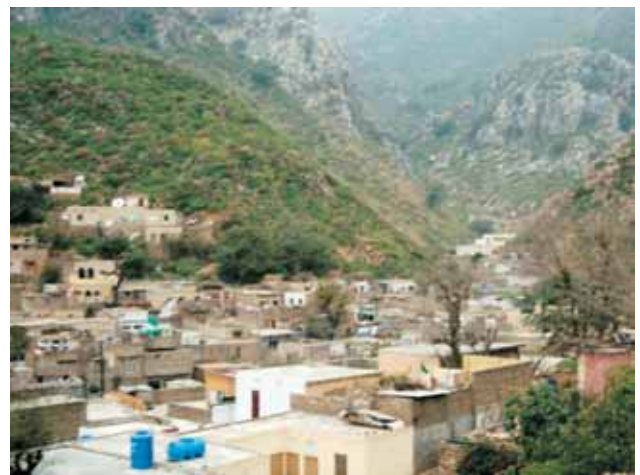
The CDA undertook the development of Saidpur into a ‘model tourist village’. Around 400 million Pak Rupees were spent on the project. The renovation aimed to preserve Saidpur as a cultural heritage site for tourists and a tourist spot for local residents of Islamabad. The renovation started in 2006 (Figure 6) and work was carried out on the main historic structures until 2008. A number of interventions took place to improve the physical environment and to restore/ renovate the historical buildings and to improve cultural and economic conditions of the village. Saidpur Village was developed as a model village to attract tourists on the lines of folk villages in European countries (Khan and Imdad, 2010).

Figure 6: Saidpur at the start of the renovation (2006)

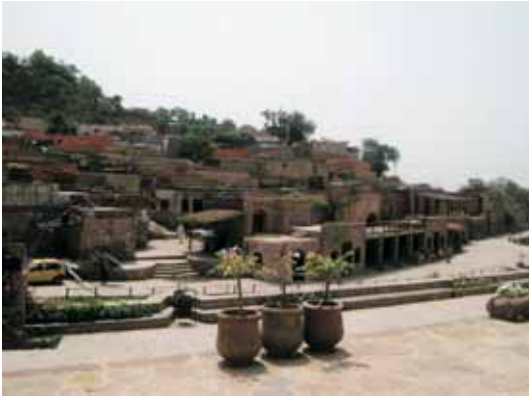
The masterplan included the plan to develop a major arts and crafts village nearby, with an intention to house the artisans, their shops and display booths. The village center would be planned to be developed to house a combination of restaurants, cafes, a museum, an art gallery and handicraft and souvenir shops showcasing local goods (Figure 7).

Figure 7: Initial renovation of village in 2006

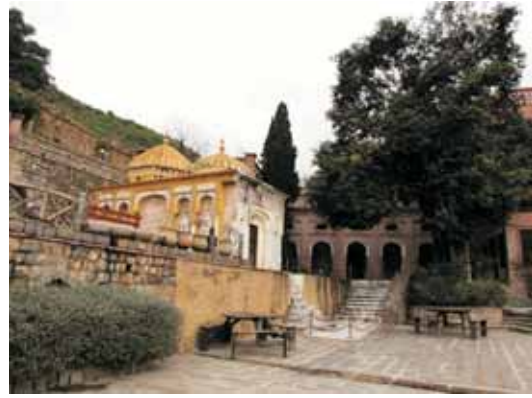
Figure 8: The complex of Temple Mandir and dharamshala

The C.D.A. has devoted its maximum effort on working on the existing historic structures at the site; the old *mandir* and *dharamshala* (Figure 8). The *dharamshala* renovation was carried out in a sensitive manner by retaining its character by using near to original materials, colors and textures. The original marble floor of the *dharamshala*, dating from the early 1900s was in fairly good condition, this was cleaned and retained.

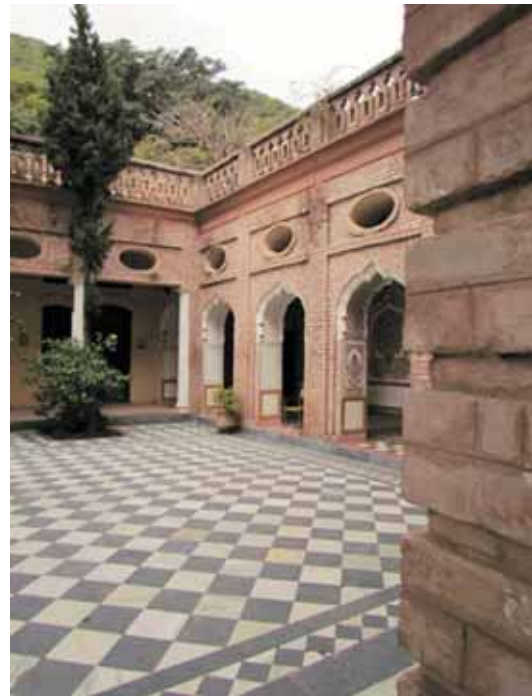
Figure 9: View of the renovated museum and marble flooring

dharamshala/ school into a museum/ gallery space was a very positive step in the renovation of the building. The original brick façade of the *dharamshala* was retained and this added to the character of the buildings. However, the internal walls of the veranda were covered with brightly painted floral patterns. The patterns and colors were more reminiscent of truck art and had no connection with the original buildings. This was contrary to the standards for historic restoration, that states that designs that are never executed historically should not be constructed (Figure 10).

The *dharamshala* was converted into a museum for the city of Islamabad (Figure 9). The re-adaptive use of the

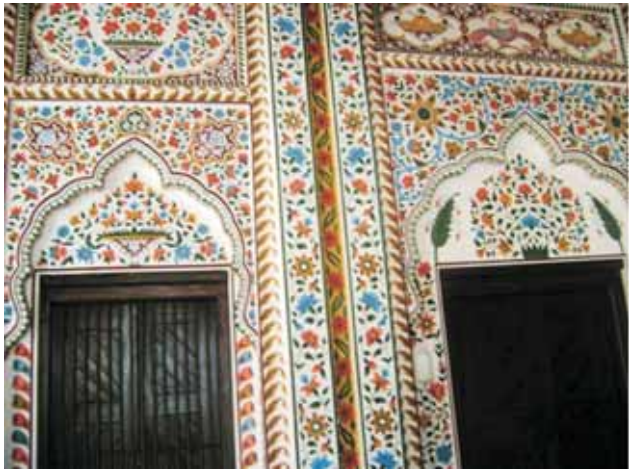
Figure 10: Repainted walls of the *dharamshala*

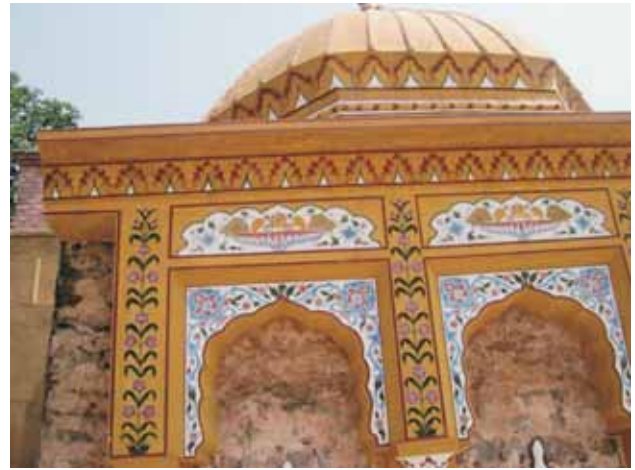
Figure 11: Repainted façade of the temple

The restoration fell short on these aspects and no studies or documentation of existing buildings were carried out to determine the existing decorative elements. All the buildings were white washed losing all of the original existing details of the *mandir* and temple. The over-painting of garish and inauthentic motifs gave the whole renovation an artificial look. The patterns of birds and the *Jahangiri* inspired fruit bowls were details not indigenous to the area. These details reduced the integrity of the renovation (Figure 11).

The Athens Charter for Restoration of Historic Monuments (ICOMOS, 1931) states, ‘proposed restoration projects are to be subjected to knowledgeable criticism to prevent mistakes which will cause loss of character and historical values to the structures.’ In the case of Saidpur Village, studies on the history and architecture of the village were not carried out and experts in conservation/ restoration were not involved.

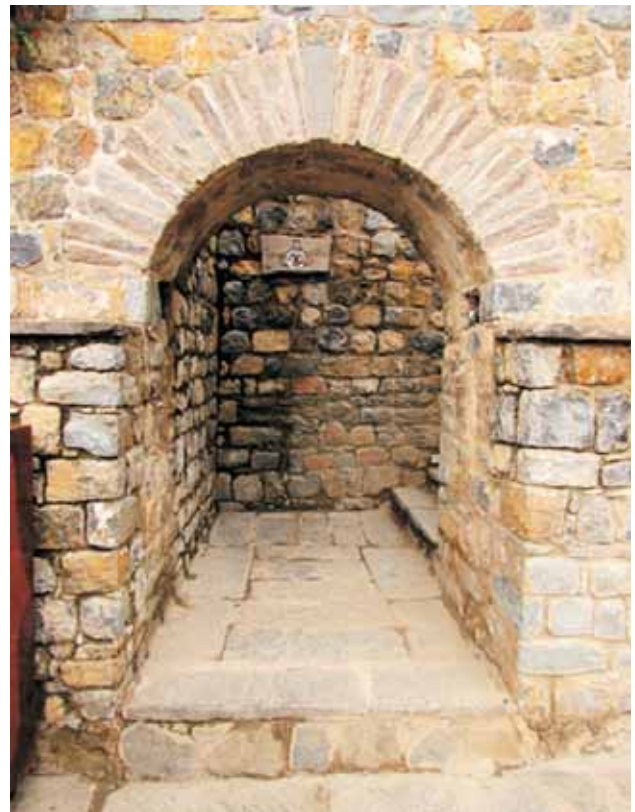
New buildings were allocated to restaurants (*Des Pardes*) with outdoor seating that spills into the temple courtyard (Figures 12, 13). Two *chattri* (umbrella) structures were erected at the entrance. The design and size of the two structures seemed out of place within the historic complex. Aesthetically they fail to add anything to the space (Figure 14).

Figure 12: Doorway and steps leading to hotspot on hillside

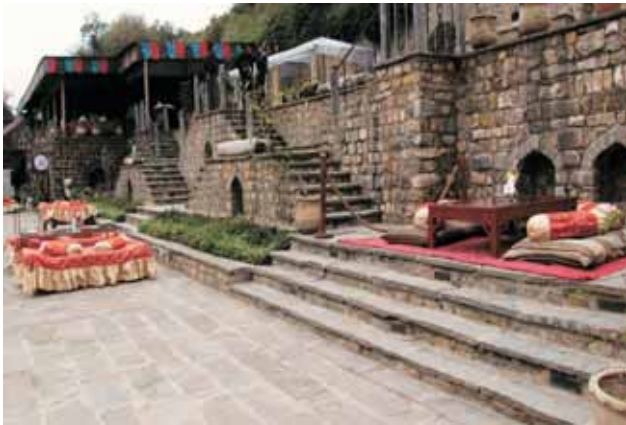
Figure 13: Seating area of restaurant

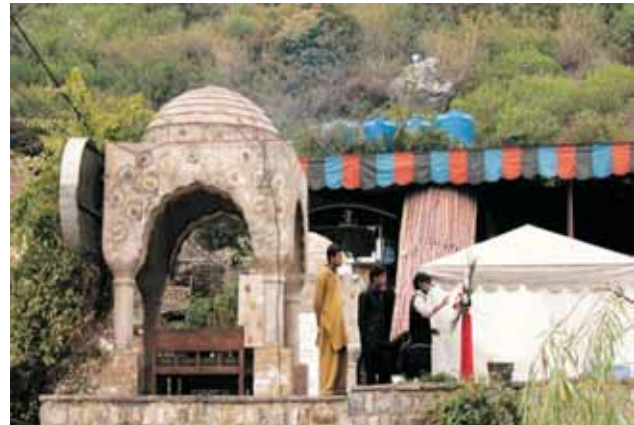
Figure 14: Chattri structure at the entrance of temple complex

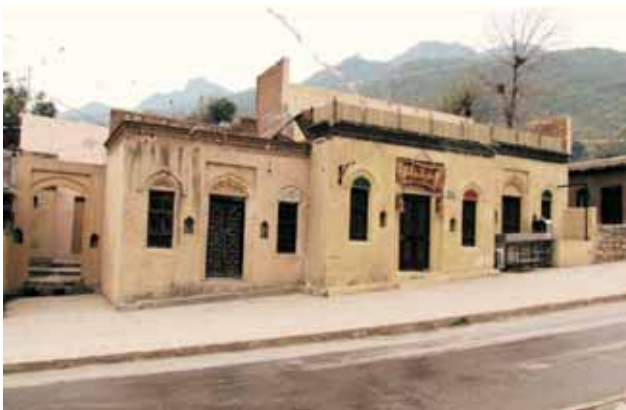
A lot of effort was made in improving the approach to the village by cleaning up the old buildings along the road. The houses on both sides of the entrance were vacated and their facades were rebuilt in stone to give a traditional look. The street now appears neater and cleaner but does not reflect the layout of a traditional street. These new premises were converted into expensive shops and cafes (Figures 16, 17).

Figure 16: Reconstructed facades of shops

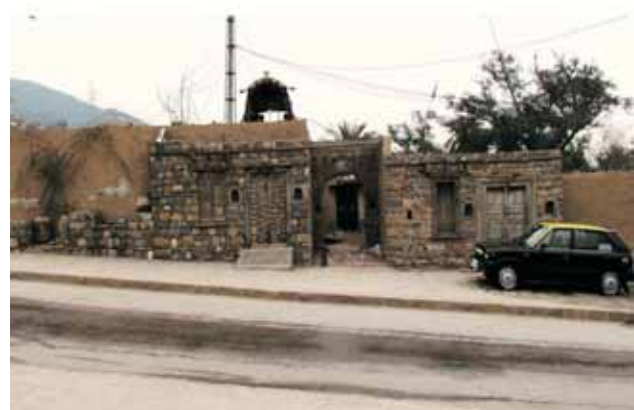
Figure 17: Reconstruction work

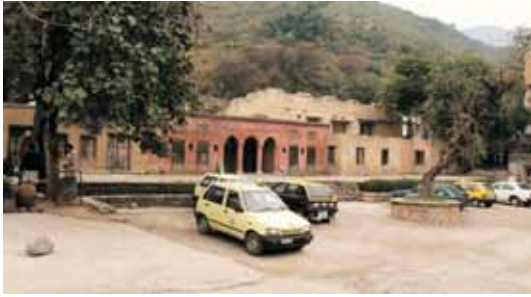
Figure 18: Parking outside village

The main road leading to the village opened up into a large parking area. This vast parking space can accommodate almost 500 vehicles (Figure 18).

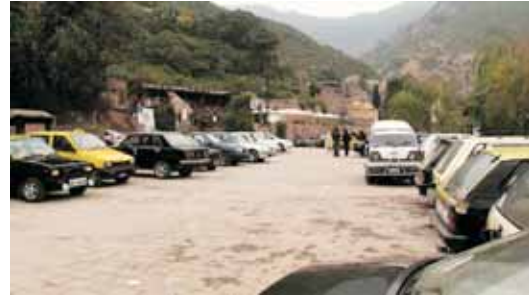
Figure 19: Parking areas inside the village

The parking has also been bought into the central part of the village which used to be a pedestrian area (Figure 19). The new businesses have exerted pressure on the authorities and as a result cars are parked next to the restaurants. A better plan would have been to keep the center of the Village as a pedestrian area, this would have added to the historic fabric and ambience of Saidpur. Instead the area now offers a commercial look with multiple restaurants and cars.

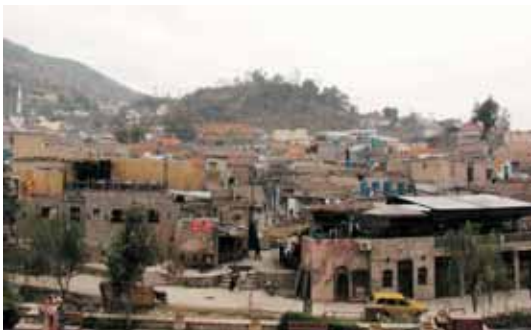
The central *nalla* of the Village was envisaged to be the hub of all activities and two major restaurants and some souvenir shops were placed on both sides to increase tourism. The village *nalla* was also uplifted by paving its sides. The façades of the houses next to this area were also uplifted by plastering them with mud and painting them in 'indigenous colours' (Figure 20).

Figure 20: Façades of houses painted in orange

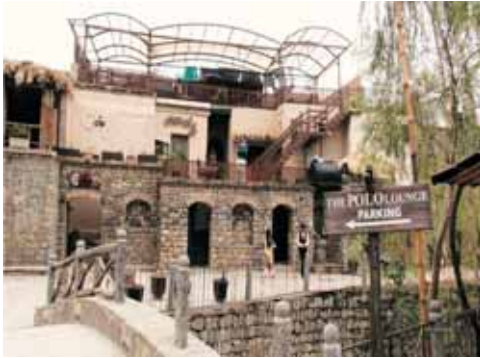
Figure 23: Polo lounge occupies the area where the potter's shops were located

With time however, the potters and their shops were pushed out of the area and posh restaurants dot the front of the Village (Figure 23).

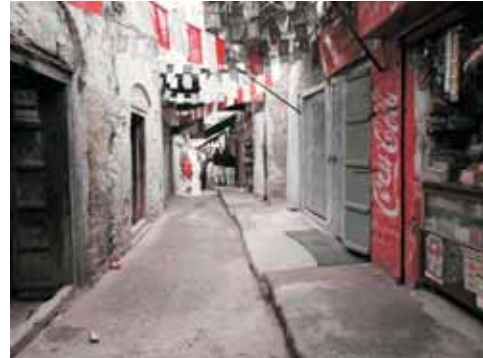
The central area of the Village was also paved and the nearby main street was paved with stone and concrete. The open drains were covered and the façades were cleaned up. Many façades were redone to reflect “history” with various style arched openings and doors (Figures 24, 25).

Figure 24: Paved street and reconstructed facade

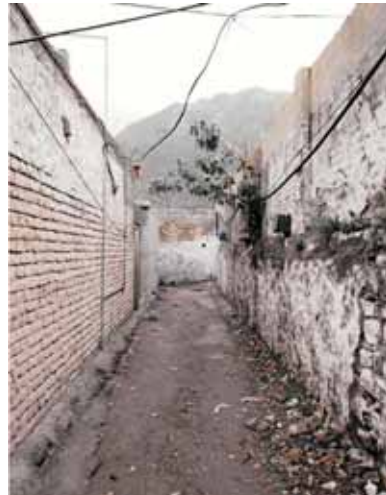
But further away from the tourist center the streets remain broken and filthy (Figure 26). The storm water *nalla* was also paved and maintained near the center of the village (Figure 27) but towards the rear of the village it was full of garbage and sewage (Figures 28, 29). Due to lack of a proper garbage disposal system the *nalla* became a dumping place for refuse. The open sewers and drains from the houses flow into the central *nalla*.

Figure 26: Unpaved street

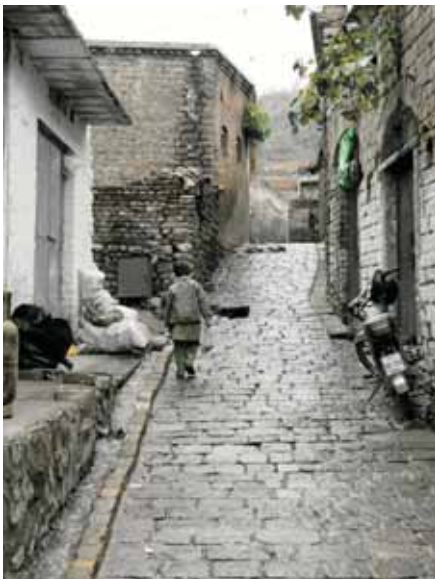
Figure 25: Stone paved street

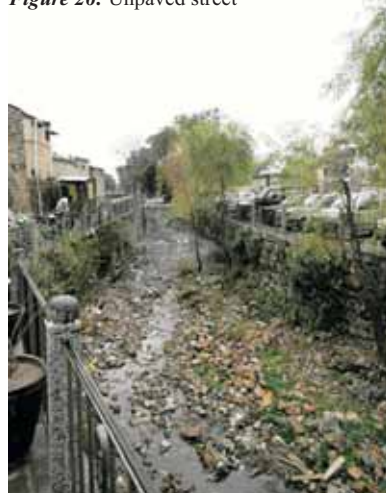
Figure 27: Nalla paved in central area

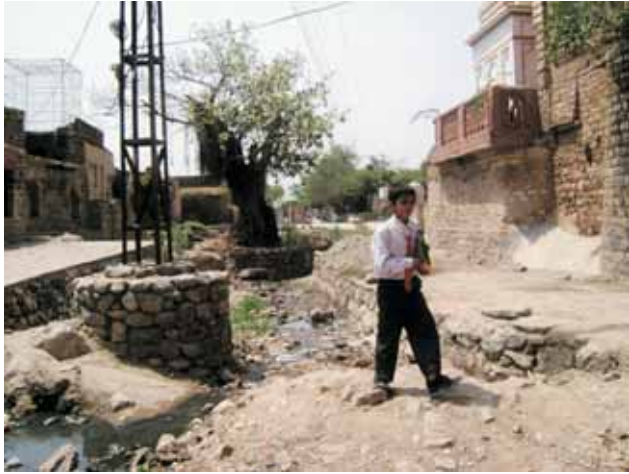
The C.D.A. has not completed the project to remove dirty water and sewer waste away from the *nalla*. The open sewers and their waste water in the *nalla* added to the smell and visual pollution of the village.

Figure-28: Garbage littered *nalla* in village

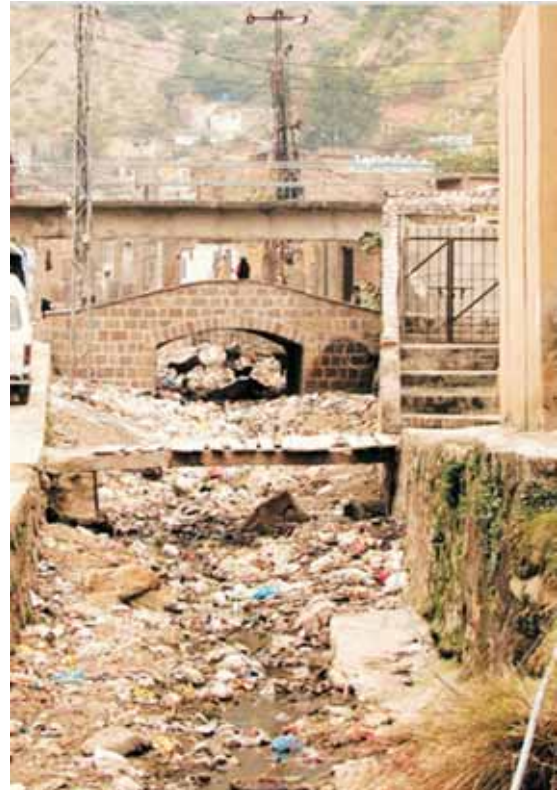
Due to lack of garbage disposal and adequate waste collection facilities, the environmental improvements envisaged for the site were not realized. The quality of life for the ordinary resident of the village did not improve. Streets and stairways

Figure-29: The *nalla* is filled with garbage between houses

throughout the village remained unpaved and broken. The sewage lines were non-existent. The waste water and sewage flew through the streets unattended.

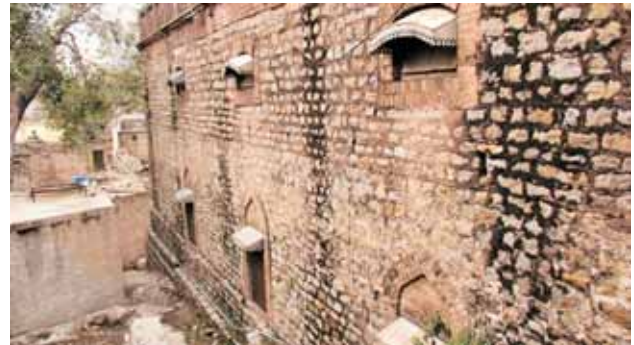
Figure-30: The back facade of the *dharamshala*

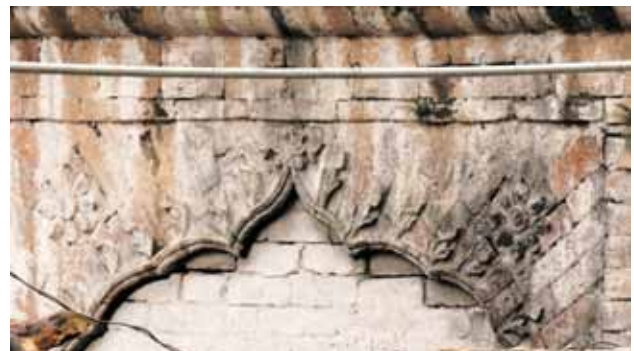
Figure-31: Decorative brick work on a doorway

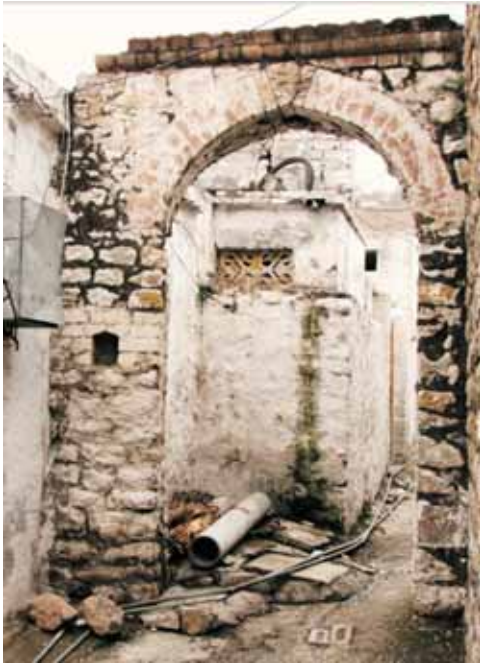
Figure-32: Historic doorway in village

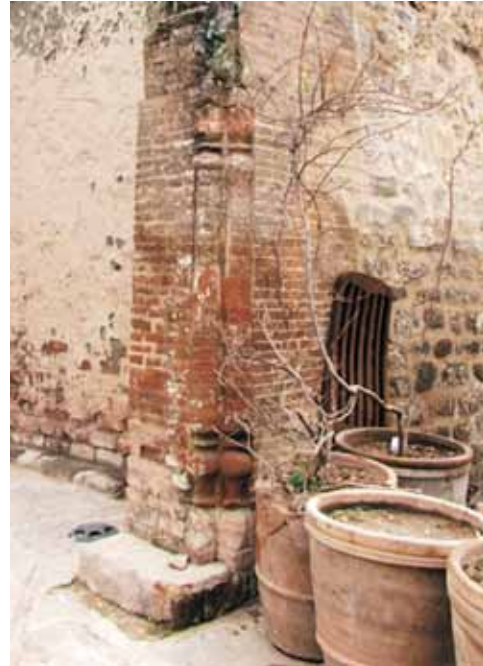
Figure-33: Remnant of old decorative brick columns

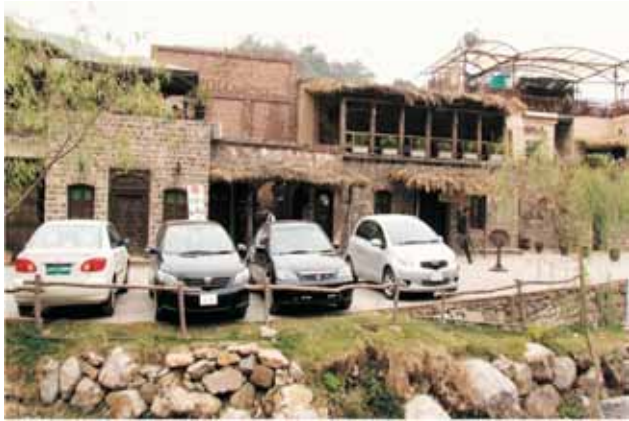
Conclusively, the Saidpur Village has not become more livable after the renovation works. The development did not improve the life of the residents of the village and any income that has been generated by tourists goes to the posh restaurants managed by outsiders and a forced sense of history has been given to the area (Figure 34).

Figure-34: Fancy cars outside an exclusive restaurant

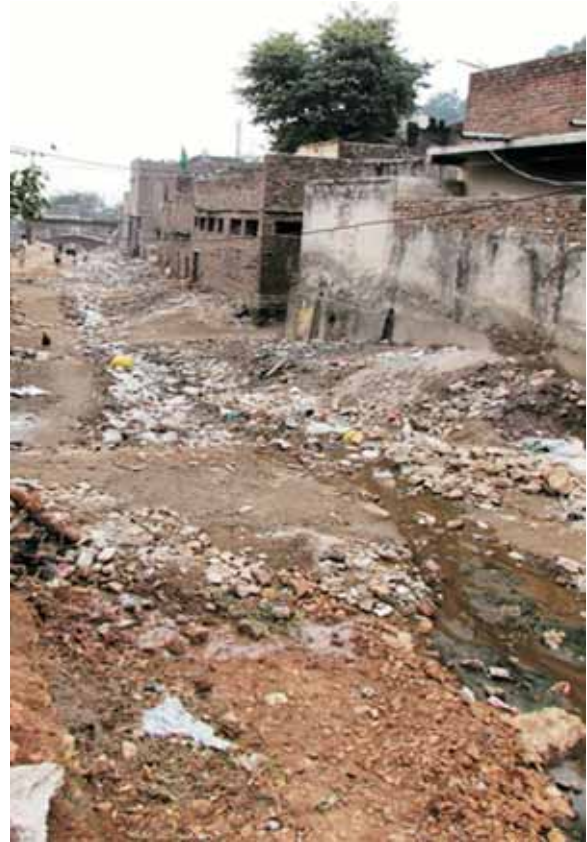
Similarly the use of mud plaster over the existing houses to give them an indigenous look was visually appealing, but care should have been exercised in giving a diversified look by employing brick, mud and stone as building materials, as some buildings made entirely of stone look out of place. Furthermore, the painting of various houses dotted around the village with an ochre-orange tone failed to produce an overall atmosphere of harmony, as the lanes and pathways were broken and depleted and only the buildings were attended to (Figure 35).

Figure-35: View of village street
