DOCUMENTING THE ARCHITECTURAL CHARACTERISTICS OF CATHEDRAL CHURCH OF RESURRECTION, LAHORE

ABSTRACT

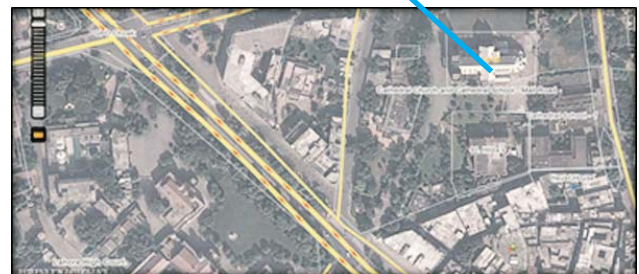
Figure-2: Aerial view of the Cathedral Church of the Resurrection.

The Cathedral Church of the Resurrection is located on the Mall Road, just opposite the Lahore High Court. The Cathedral is also adjacent to McLeod Fane Road. All of these roads have a continuous flow of traffic causing noise. Inside the site is a green lawn with dense vegetation, and the eye-catching monument of the Cathedral of the Resurrection (Figure 2).

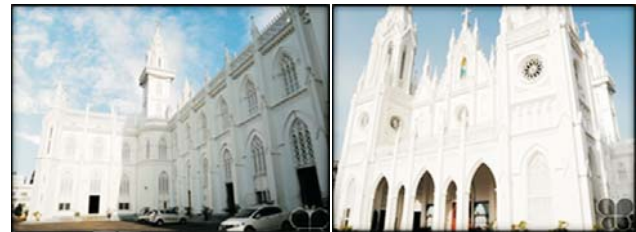
Figure-3: The Lady of Dolours Church, India.

Gothic architectural features. Another example of Gothic Architecture in the sub-continent is the Lady of Dolours Church, located in Thrissur, Kerala, India (Figure 3). This is one of the largest church in India. It was established in 1814, and the existing structure was constructed in 1929. Its interior decorations and paintings are well maintained (Figure 4) (India Opines, 2017).

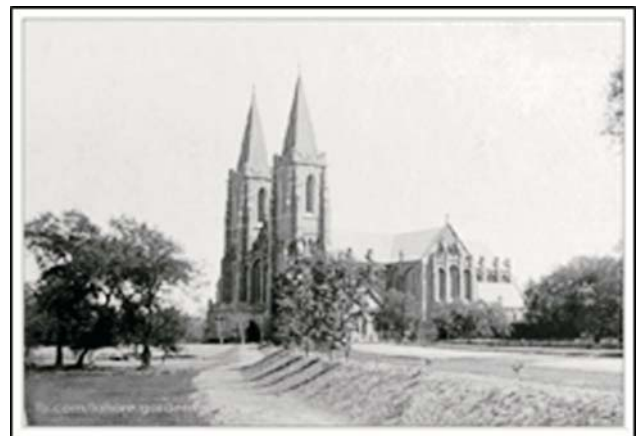
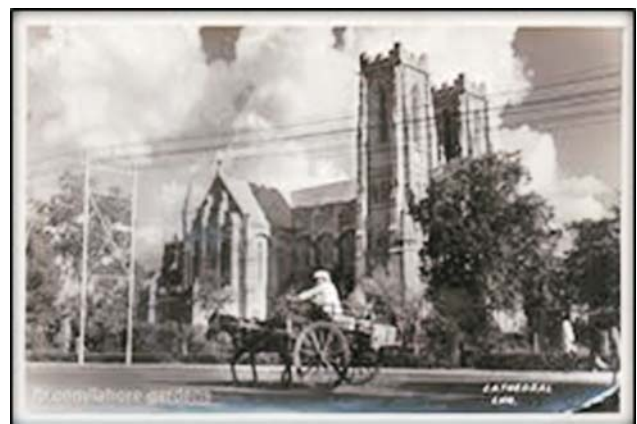
The foundation of the Cathedral was laid in 1874, and the structure was completed in January 1887. However, the two towers with tall spires were added in 1898, (Figure 5). The spires were demolished after the earthquake of 1911 for safety reasons (Figure 6) (Clerkin, 2009).

Figure-5: The Cathedral Church of the Resurrection with Spires.

Figure-6: The Cathedral Church of the Resurrection without Spires.

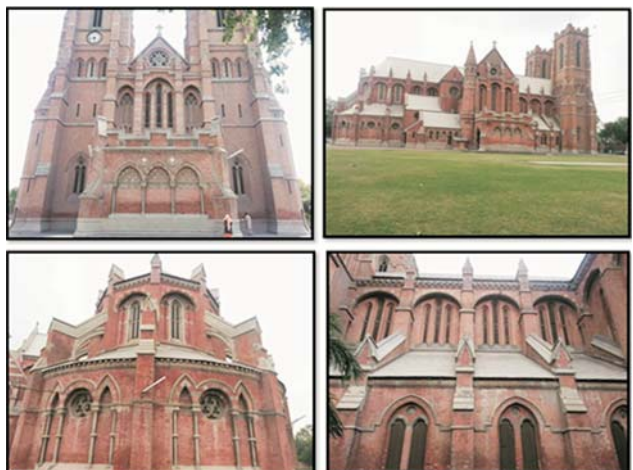
Figure-11: Four-sided views of the Cathedral.

The structure seems to be intact but the brick courses have deteriorated upto three to four feet above ground level. The four-sided views of the Cathedral are shown in Figure 11. The plastered decorative features on the flying buttresses are also in poor condition. These red bricks were prepared from soil specially brought from Jhelum, Pakistan (Aijazuddin, 2004). The plaster was composed of cement and sand.

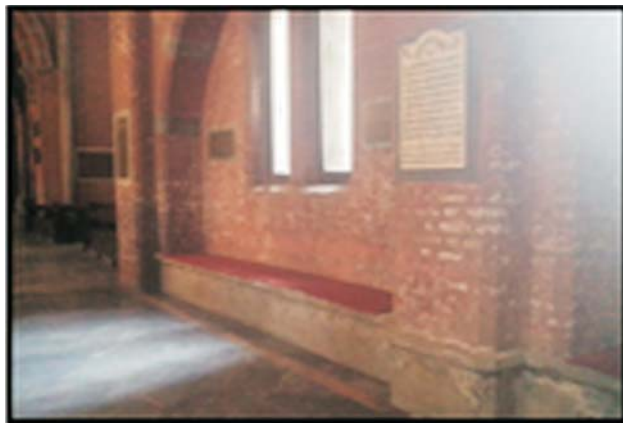
Figure-13: The northern interior wall affected by dampness.

The dampness has affected both the exterior and interior walls which of the Cathedral (Figure 13). The northern aisle's inner surface area where dampness has affected the walls is about three to four feet above the foundation.

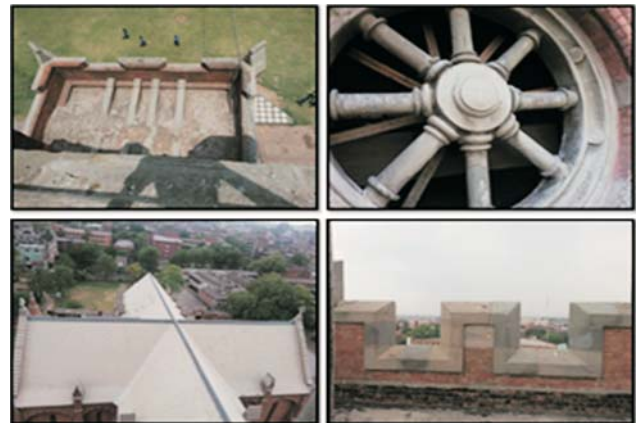
Figure-14: Different views of roof top.

The sloping roof is in better condition because it was repaired in 2008. Other surface areas of the roof, including the nave and aisles top covering (barrel vault), side entrances and parapet walls need to be renovated (Figure 14).

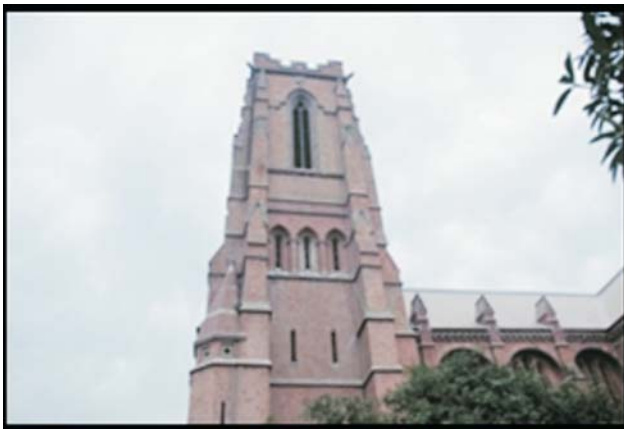
As discussed earlier, the bell tower had tall steeples at the top, which were removed after the earthquake in 1911, because of their unstable condition. The existing condition of the tower is shown in Figure 17. From the ground, three feet of the brick foundation has been affected by dampness. The rest of the facade has some minor deterioration in the plastered areas.

Figure-17: View of the Tower reaching great heights including gothic details of pointed arches, buttresses, trefoil openings, and sloping roof at the rear.

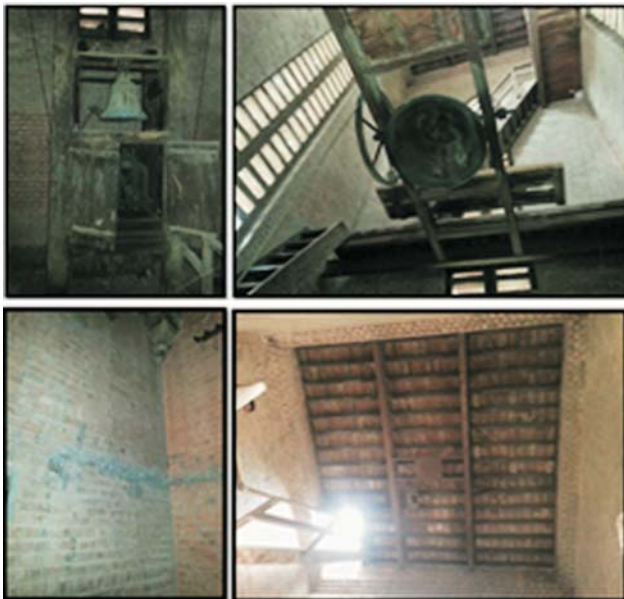
Figure-19: Views of Bell room.

Figure 18 shows the stair hall leading to the bells at the top and the approach ladder to the bell tower. The different views of the interior of the bell room at the top of the bell tower are shown in Figure 19. The wall structures are intact; the wooden ladders, approach to the wooden roof and the hanging bells are in good condition. The wooden cabinets are however in poor condition.

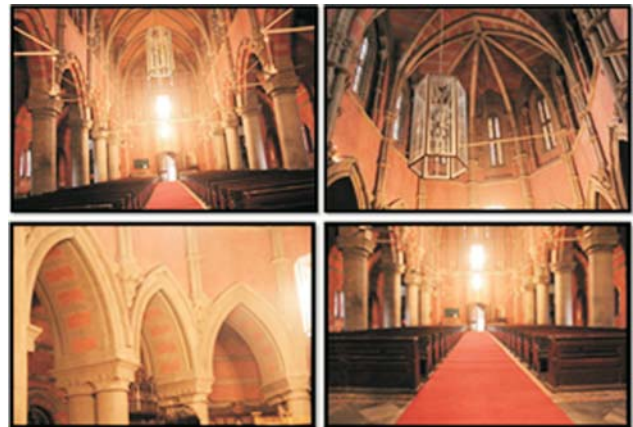
Figure-20: Nave with side aisles of the main hall.

The main hall consists of a nave with side aisles (Figure 20). This hall is the main area of the Cathedral and shows its grandiosity. Upon entering through the main door, one is struck by its height and amazing gothic features of arcades, piers, alternations, traceries and stained glass windows.

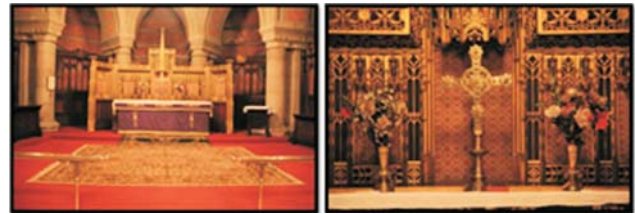
Figure-21: Main altar of the Cathedral.

In Christianity, the altar is considered to be the most sacred part of the Cathedral and is used for ritual ceremonies (Watts, 1883). The altar of this Cathedral is located at the eastern half surrounded by an ambulatory (Figure 21). It has a prominent table with golden background containing ritual components.

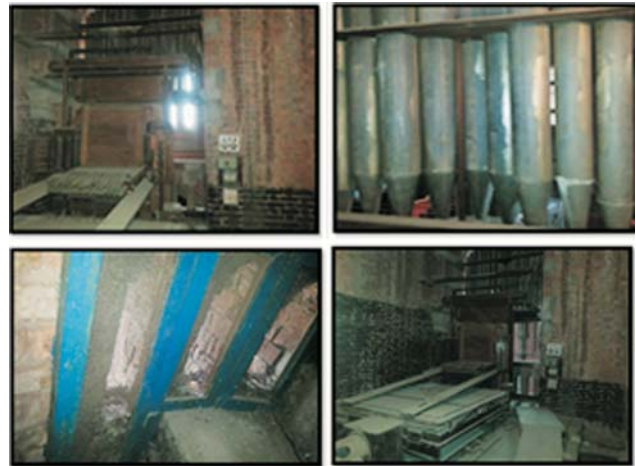
Figure-22: Views of the Orchestra room of the Cathedral.

This is the most extensively damaged part of the Cathedral. Rain water coming from the damaged roof has ruined the historical orchestra room. Further, the termites have damaged its internal and wooden areas. The floor of the orchestra room is totally damaged due to rainwater and termites. Different views of the orchestra room are shown in Figure 22.

On the basis of the documentation and analysis of the Cathedral it can be concluded that the building, which appears to be in sound condition, has many areas that need to be repaired immediately. The significance of its heritage should be of prime importance. The materials to be used for its repair should adhere to the international rules for conservation of monuments. Starting with the walls, serious consideration should be given to the dampness that has affected the walls up to the height of three feet from the ground and further at the edges of the roof. Surface treatment is required and the source of moisture needs to be removed, which can be achieved by water proofing the walls from their base and on the edge of the roof. The plaster of the surface decorations both inside and outside of the cathedral, must also be repaired. The major element of neglect of the Cathedral, that is unique to its own kind, is the Orchestra Room which should be maintained and made operational. It has been ruined by voracious termites. Proper repair and termite treatment will enhance the value of this distinctive
