# AN ANALYTICAL STUDY OF COLONIAL AND CONTEMPORARY BRICKS FROM THE BUILDINGS OF LAHORE, PAKISTAN

## ABSTRACT

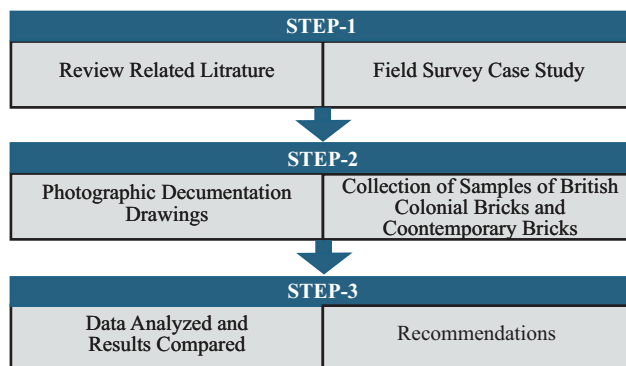
Figure-1: The schematic layout of research methodology.

This research was divided into three major phases (Figure 1). In the first phase the related literature was reviewed which was focused on the study of brick in the British colonial period in Lahore city. The second phase involved the field survey of colonial and contemporary buildings in Lahore. The next phase included collection of proper samples of the colonial and contemporary building bricks from various buildings constructed during different times. The collected samples were tested in the laboratory to generate the required data. The buildings were also physically examined to identify various causes of deterioration. These were further supported by photographic evidence and drawings. After collection of the data, it was analyzed and compared with respect to chemical composition, clay quality, clay selection, shapes, strength, manufacturing process, burning process and uses in the buildings, and then the conclusion were drawn from the comparative analysis.

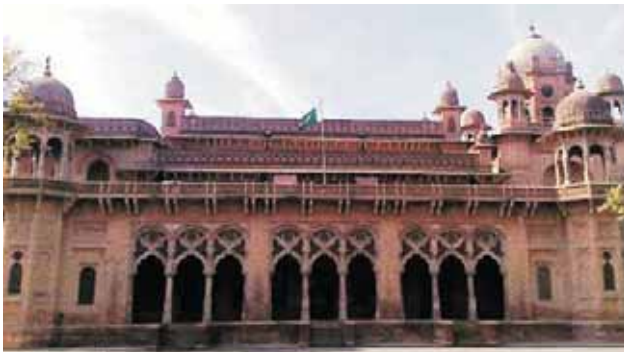
Figure-2: The elevation of old building of Aitchison College Lahore.

The Aitchison College has a strong historical background and rich architectural edifices belonging to British colonial period. The old building of Aitchison College is the best example of brick structure of colonial construction (Figures 2 and 3). Completed in 1886, seven colonial buildings which were constructed with common clay bricks with exposed bricks on building façades are scattered at the site of Aitchison College.

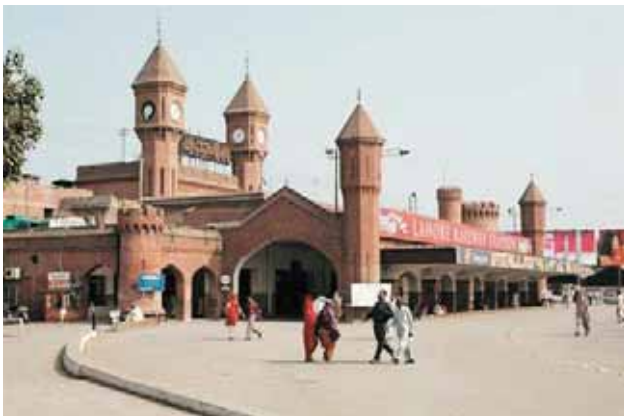
Figure-4: Front view of railway station of Lahore.

The Railway station of Lahore (Figure 4) is another example of British colonial building in the city of Lahore. The main construction materials of the building are commonly available clay brick and steel trusses with wooden doors/windows. The façade of the railway station is artistically developed, creating a balance with conical minarets which erect on an octagonal base and round shape minarets. This building was constructed by British colonists' architects between 1859-1860 at the cost of half a million Rupees. It is located at the junction of Lahore-Amritsar railway line. The railway network of the subcontinent was developed by the British and is one of their long-lasting contributions to the culture and infrastructure of this region (Chopra and Patwardhan, 1954).

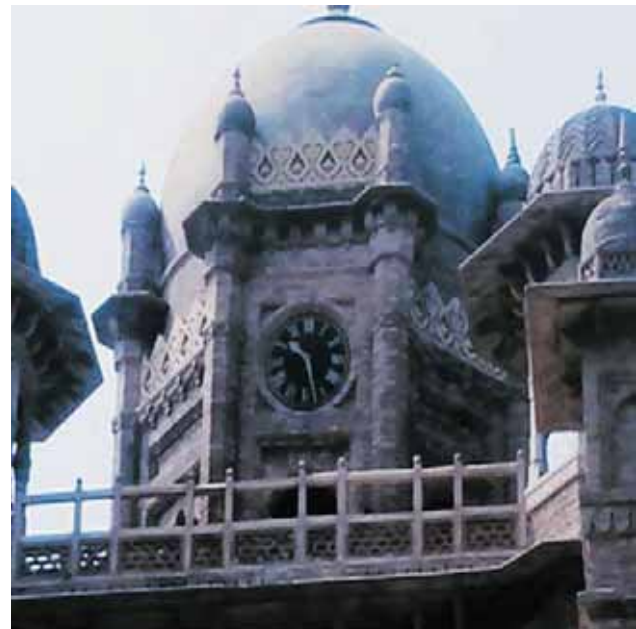
Figure-3: Main dome decorated with mini domes of Aitchison College.

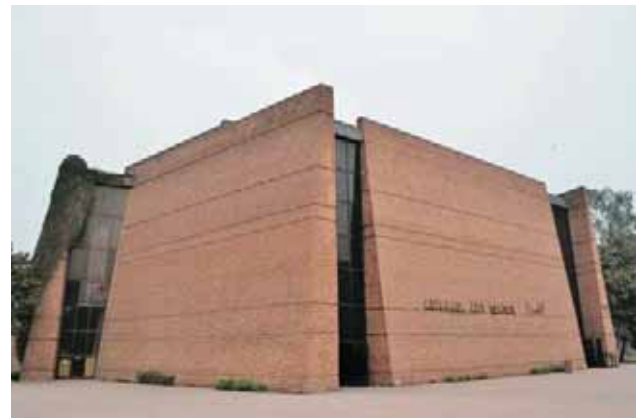
Figure-5: Alhamra Arts Council Hall No.1.

The Alhamra Arts Council Lahore (Figure 5) is the main complex for cultural activities for the people of Lahore city and its vicinity and for people from all over Pakistan. It is situated on the Mall Road, now known as Shahrah Quaid-e-Azam (after the founder of Pakistan). The Arts Complex was designed by Architect Nayyar Ali Dada. The Alhamra Hall-1 is the single cultural theater visible from the Mall Road and the access of this portion is directly from the Mall Road. The form of the blocks used in its construction are mostly octagonal in shape. The architectural style of the complex is unique and distinctive, reflecting modern architecture. It is a good example of a building in Lahore which is constructed with common clay bricks locally produced. The architect used a local building material and very artfully exposed bricks on the façades of all the building blocks in the complex. The thick and huge structure with exposed common clay brick walls represents Mughal architectural forms.

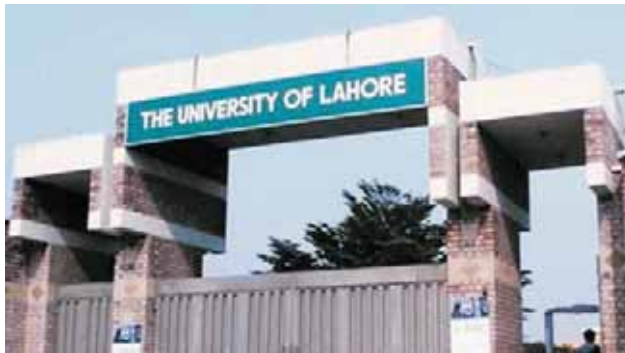
Figure-6: Main gate of Lahore University, Raiwind Road, Lahore with brick pillars.

The 2nd campus of the University of Lahore is (Figures 6 and 7) located on Defense Road, near the Raiwind Road Lahore. The University houses Medical Engineering and Architecture Departments, and locally produced clay brick is predominantly used as a construction material.

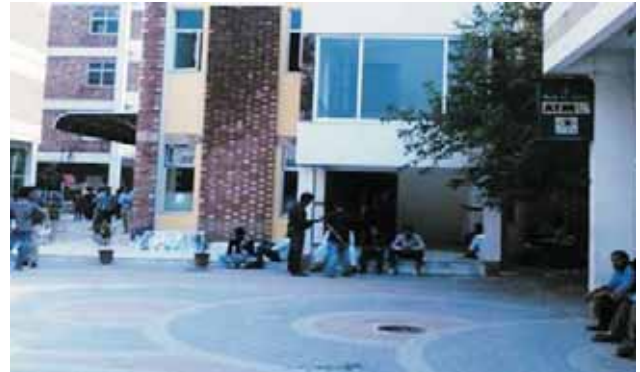
Figure-7: Internal view of Lahore University.

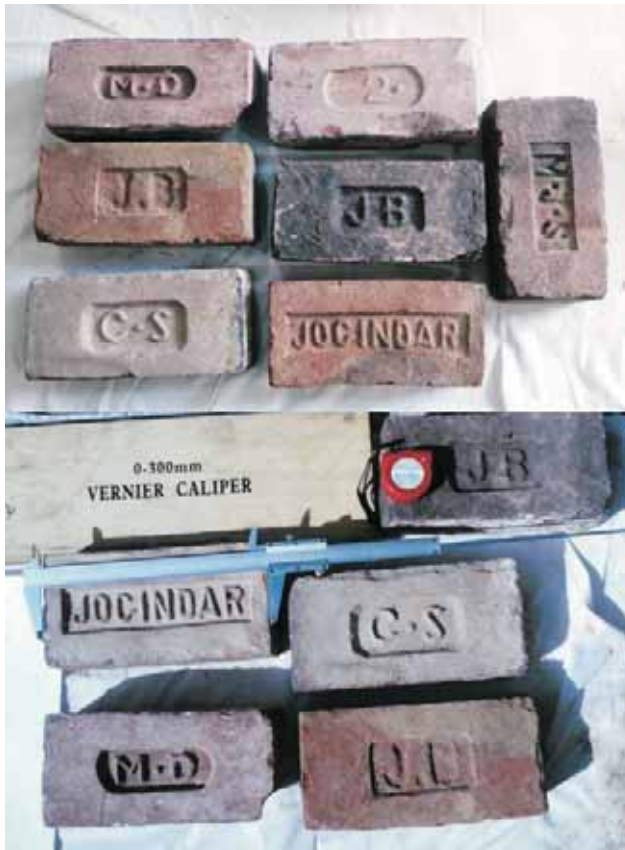
Figure-8: The samples of bricks used in British colonial buildings (With Marks: M. D., 2., J. B. K. J S., C. S., JOCINDAR).

of the colonial bricks was found to be 9.0” in length 4.5” width and 2.9” thickness (Figure 8). Most of the colonial buildings were built at the end of 19th century.

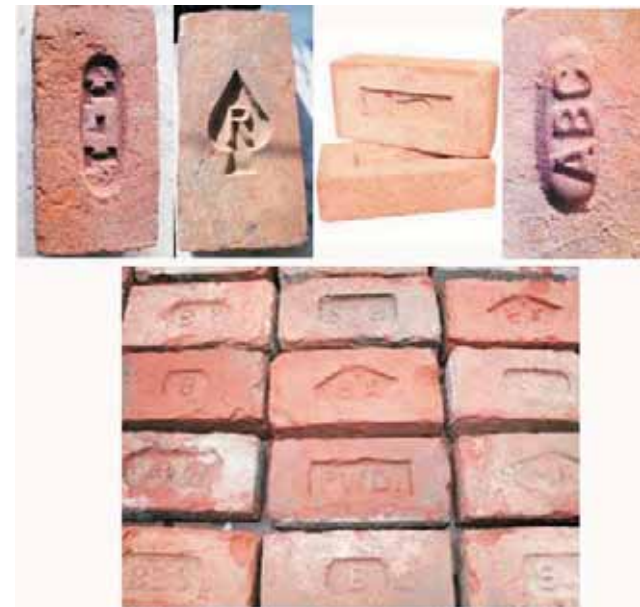
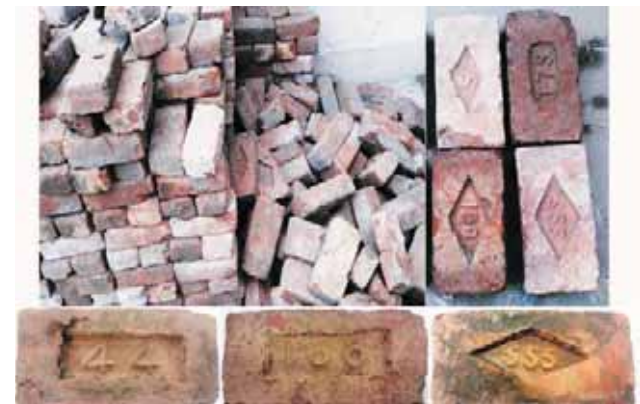
A comparison of the colonial bricks was done with the contemporary bricks available in the market. It was found that different sizes of contemporary bricks are available in the brick market (Figures 9 and 10). Mostly available bricks were under sized and only some brick kilns manufactured a special quality of brick and produced standard sized bricks.

Figure-9: Samples of contemporary bricks used in building construction.

Figure-10: Samples of bricks used in contemporary building.

The standard sized bricks were available at higher prices than economical class which were under sized. The special quality bricks which met the standard size were not used in ordinary building construction due to high cost. Other economical class bricks, which were introduced as first class brick by the kiln owners, were mostly used in the construction. These under sized bricks increased the cost of construction in the form of excessive use of cement in mortar and plaster.
