# A STUDY OF THE CONSERVATION SIGNIFICANCE OF PIRZADA MANSION, LAHORE, PAKISTAN

Built heritage is not merely about living quarters, but it also reflects the living standards, cultural norms and values of any society. The old built heritage gives references to the past, the way people used to live and their living arrangements. This is done by understanding the spatial layouts of that particular built heritage. This research aims to focus on documenting a historic building from the colonial period located in the walled city of Lahore, to highlight the need and significance of conservation of these historical buildings that are neglected and under threat. The method of research adopted for this paper was to document this building via an ethnographic analysis using photographic surveys, questionnaires, interviews from government authorities (Walled City of Lahore Authority) and local residents, and several site visits for detailed documentation. This paper aims to identify the aesthetics and structural threats and other aspects of the Pirzada Mansion, which is a splendid example of the British colonial period and is located in Walled City of Lahore.

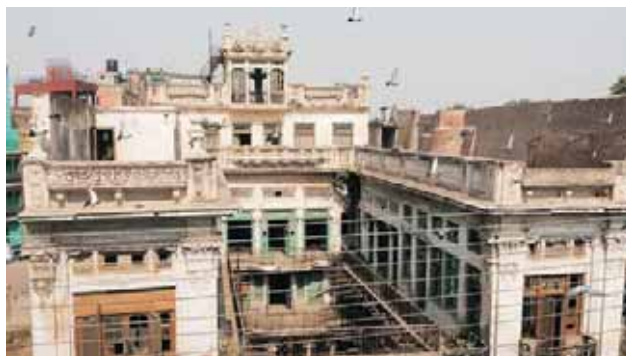
Figure-5: External view of the Pirzada Mansion.

After a detailed study of the Pirzada Mansion many historical and cultural evidences were revealed, that indicated its architectural significance (Figures 5 and 6). Pirzada Mansion is one gem among all the colonial era buildings found here. It seems to be inspired in style and design by buildings conspicuously popular among the Sikhs, primarily the

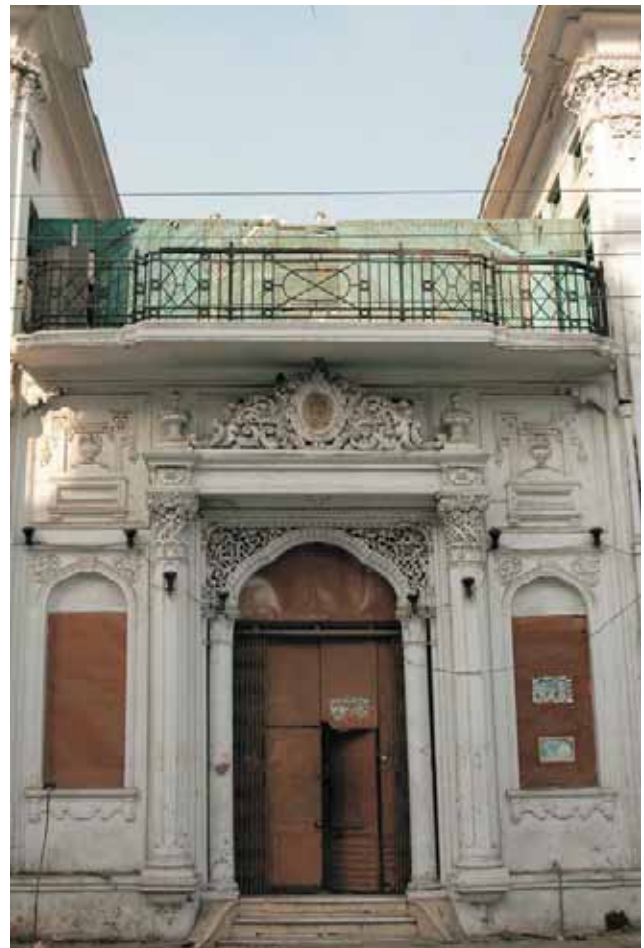
Figure-4: Front view of Pirzada Mansion.

The Fort Road, along the southern façade and main entrance of the *haveli*, has since then become one of the main vehicular routes into the 'Walled City'. The northern (rear) gate of the *haveli* opens into a courtyard across which lies the famous 'Cuckoo's Café' (Figure 4). The eastern wall faces the outer fortifications of the Lahore Fort. To the west of the consolidated property, a 9 ft wide lane connects the Fort Road to the rear courtyard space.

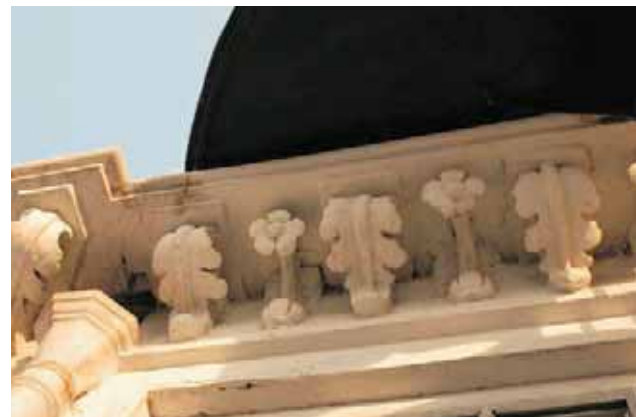
Figure-8: Stucco Pillar.

One of the major distinctive features of Sikh shrines seems to be the presence of pillars and pilasters. The shafts are mostly plain, without any carving, except the vertical lines of accession. The capitals consist of floral or foliage designs (Figure 8). Some of the noticeable architectural features found in these building are *jharokas*, carved wooden doors, raised platforms, massive columns, floral ornamentations, Rajput architecture arches, bas-reliefs of geometrical, floral and other designs, interior – stucco work, fresco paintings, column friezes based on vine, plant, flower, bird, animal motifs and windows with *jaalis* (Arshi, 1985). The Pirzada

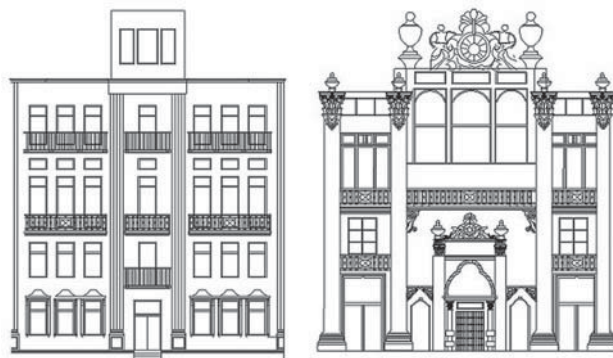
Figure-16: Front and side elevations.

The *haveli* was built in the traditional brick and 'kankar lime' construction. Repairs have been done in portland cement mortar. The columns are massive and reflect a design style belonging to that period and can be noticed in the elevation (Figure 16). The columns are based on vine, plant, flower, bird and animal motifs. (Figures 18-20). The main entrance to the *haveli* is decorated with floral designs.

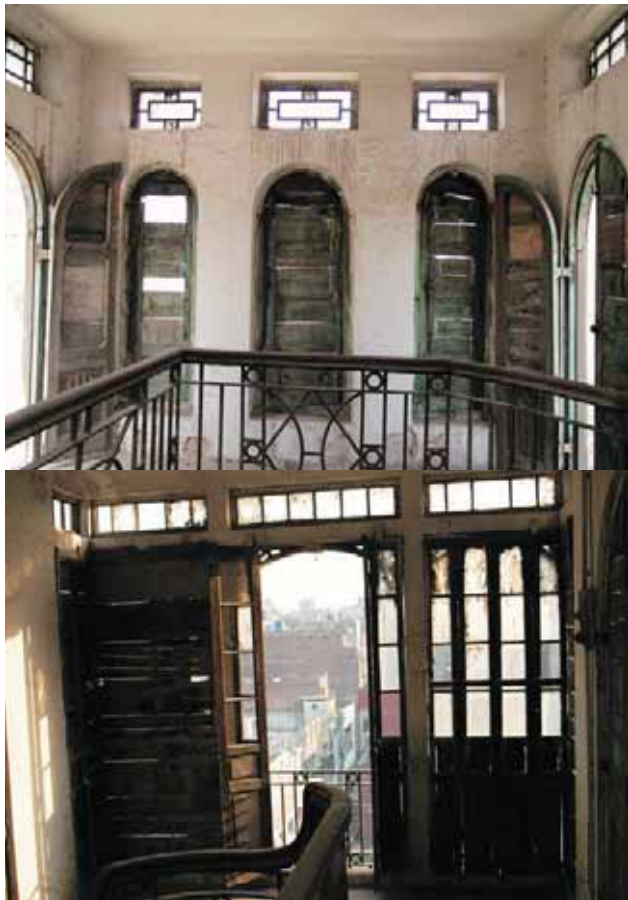
**Figure-21:** Wooden windows in the interior of the *haveli*.

In the interior, doors and windows are made of wood. They mostly have an arched profile (Figure 21). The number of windows and *jharokas* indicate the affluence of the owner. The *havelis* of the time were commonly known for the amount of wooden windows and carved doors (Fatima, 2013). The windows at the top have painted glass; they were used for generating patterns with the help of sunlight within the building. The arches were a common part of the buildings from that era, and were mostly taken from the Rajput architecture, hence the name Rajput arches (Figures 22- 23).

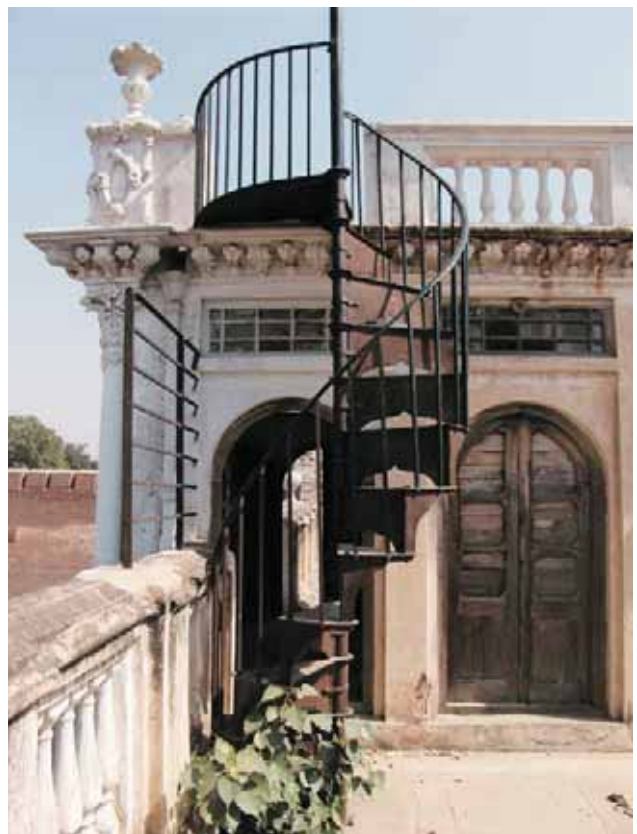
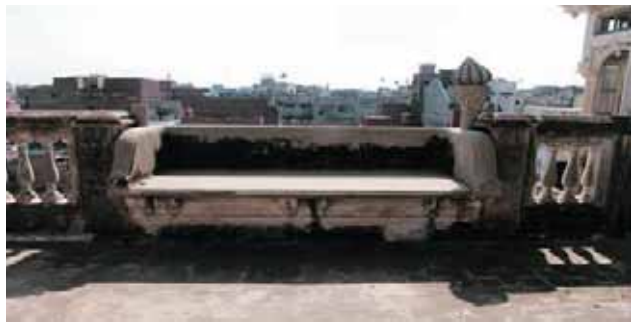
It is understandable from the plans that the *munty* floor had terraces on both sides, with a staircase on the left one (Figures 24-25). The roof top vista provided a commanding view of the Grand Badshahi Mosque, the Fort and the Gardens. As the *haveli* is located in a sandwiched plot the front façade is most important from conservation point of view. The rear elevation is shown in Figure 26.

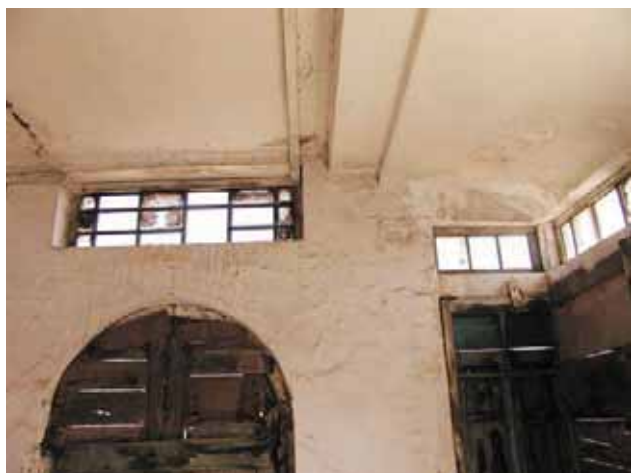
Figure-28: Dampness on walls seen in the interior.

In Lahore the average rainfall is twenty inches annually. Rain has damaged the masonry above the ground level and penetration of rainwater through capillary action has caused decay of structure internally. At some places in the *haveli*, this water penetration has also caused dampness (Figure 28).

Sensible maintenance and repair can reduce the necessity for restoration work in historic buildings, as it is extremely important to maintain the originality of historic building, with minimum interventions. A detailed conservation plan is essential before carrying out any restoration work, as it helps to decide which part of the building needs replacement and which part can be preserved after minor repair. "Any intervention must be minimum, necessary and be allowed the maximum amount of existing material to be retained." (Fielden, 2003) As already mentioned, after the foundation survey, it was clear that the foundation of the building is highly unstable. In order to enhance the structural support and to resolve the problem, piling is the immediate solution. Furthermore, regular pointing and grouting is necessary. It is necessary to restore the surrounding environment of the building. Surroundings must be kept clean. It is also necessary to use the original material in case any conservation work is done to restore the building.

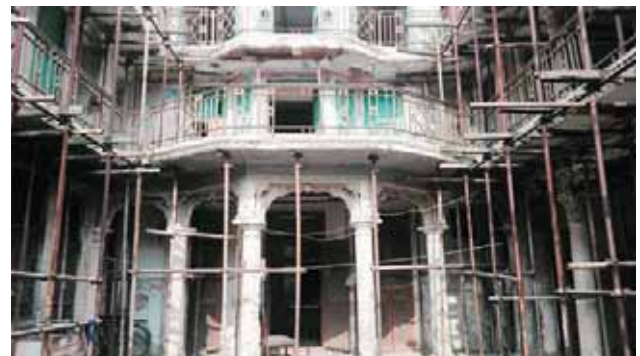
Figure-27: A view of the courtyard.

The *haveli* is located on a street that is only 35 ft wide. There are no compulsory open spaces left between buildings, and there were no bye-laws that were enforced at the time of the construction of the *haveli*. So the ventilation and air circulation is from the central courtyard of the *haveli*, that is around eighteen feet in width and thirty four feet in length, with the doors and windows opening into it (Figure 27). The peripheral walls, including the mezzanine floor are

double height with each wall having, atleast four to six windows, making the rooms well lit and having proper ventilation. Some wooden doors and windows used in its construction are still in their original condition. Each room has an open space in front of it, which become internal courtyards with openings, making the place comfortable. In winters these spaces are used to take sun bath by the family members of the *haveli* whereas in summers this courtyard helps ventilate the house. Thick walls (13 inches) also help to make the house cool in summers and warm in winters.

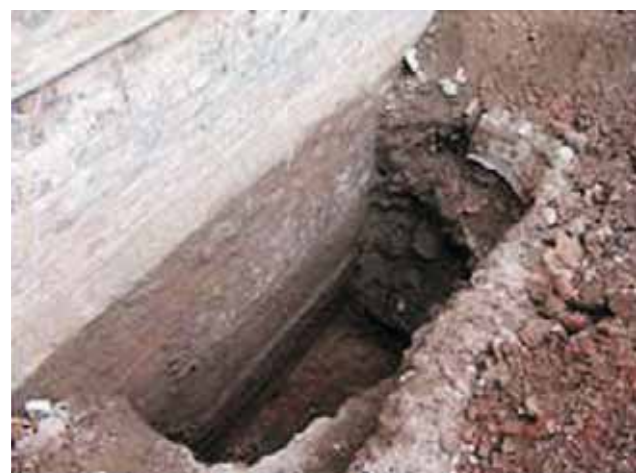
Figure-29: Unstable soil conditions in the context.

The nature of the ground and stability of soil, on which the building is erected are of an utmost importance. The site is located in an area with up to thirty feet of back fill, making it extremely unstable. Normally the back fill is upto 3 ft (Figure 29).
